Depreciation Report | 2025

Desert Gardens
554 Seymour Street
Kamloops, BC

KAS 1911—Desert Gardens
554 Seymour Street
Kamloops, BC
V2C 2G9

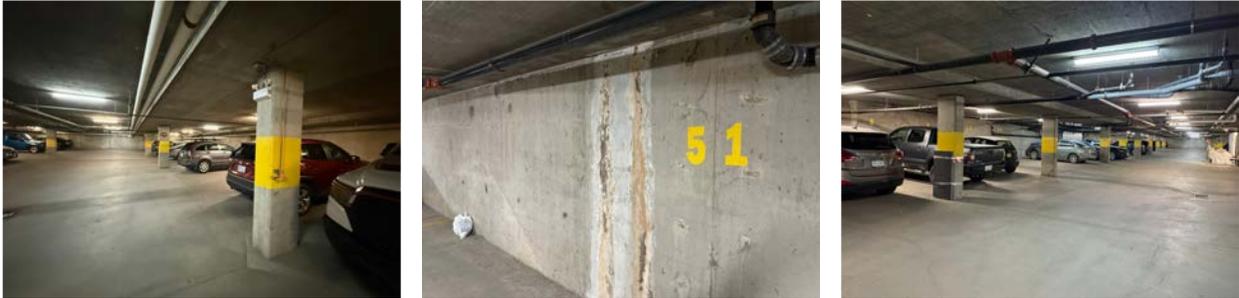
<table border="0" style="width: 100%; text-align: center;"> <tr> <td style="width: 33%;"> Estimated Current Cost \$56,200 Budget 5% </td> <td style="width: 33%;"> Projected Replacement Cost \$80,000 Due in 2035 </td> <td style="width: 33%;"> Effective Age / Lifespan (years) 25 / 35 </td> </tr> </table>		Estimated Current Cost \$56,200 Budget 5%	Projected Replacement Cost \$80,000 Due in 2035	Effective Age / Lifespan (years) 25 / 35
Estimated Current Cost \$56,200 Budget 5%	Projected Replacement Cost \$80,000 Due in 2035	Effective Age / Lifespan (years) 25 / 35		
Description	This component accounts for major repairs to the below-grade portions of the property. This includes the foundation walls and parkade: the footings, basement floors, walls, parkade ceilings, columns, and courtyard membrane.			
Condition Analysis	Based on a partial visual inspection, this component appears to be in average condition for its age. No major deficiencies were noted or reported at the time of inspection.			
Work Completed	Unknown total scope of reserve fund work completed to date.			
Scope of Work	Non-structural cracks can sometimes be injected with a sealant. We have budgeted for periodic structural stabilization work, spot replacement of damaged concrete, underdrain repairs, waterproofing, and membrane replacement. This includes excavation and compacted backfilling.			
Potential Deterioration	One of the most common problems with the substructure is cracking. Water and road salt can penetrate the surface of the concrete to the rebar. Hydraulic pressure caused by poor drainage and shifting could also cause concrete cracking. The membrane can be damaged by cracked concrete, wear and tear, and material breakdown due to age.			
Suggested Maintenance	Regular visual inspection of the walls, columns, and slab edges for signs of cracking, damage, spalling, efflorescence, debris collection, and grading that slopes towards the foundation walls. Regular application of waterproof membranes, chloride extraction, re-alkalisation, and crack repair may extend the substructure's life.

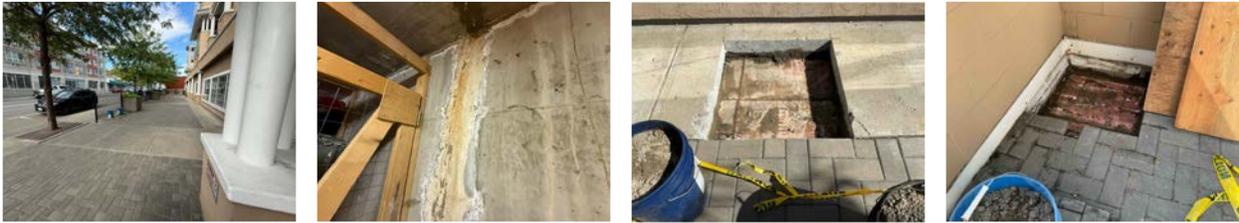
<table border="0" style="width: 100%; text-align: center;"> <tr> <td style="width: 33%;"> Estimated Current Cost \$206,200 </td> <td style="width: 33%;"> Projected Replacement Cost \$221,300 Due in 2027 </td> <td style="width: 33%;"> Effective Age / Lifespan (years) 28 / 30 </td> </tr> </table>		Estimated Current Cost \$206,200	Projected Replacement Cost \$221,300 Due in 2027	Effective Age / Lifespan (years) 28 / 30
Estimated Current Cost \$206,200	Projected Replacement Cost \$221,300 Due in 2027	Effective Age / Lifespan (years) 28 / 30		
Description	<p>This component consists of a reinforced asphaltic modified bituminous membrane installed over the structural slab, using a hot-mopped and flood-coated application method. Extruded polystyrene (XPS) insulation is positioned above the membrane, offering protection from UV exposure, mechanical wear, and extreme temperature cycles. The membrane serves as the primary waterproofing barrier for the courtyard assembly, often located beneath landscaping, pavers, and other overburden.</p>			
Condition Analysis	<p>Based on a partial visual inspection, this component appears to be in average condition for its age. No major deficiencies were noted or reported at the time of inspection.</p>			
Work Completed	<p>We have allowed for exploratory work and repair. A full review is being undertaken by the strata and the scope of work will determine the replacement costs. It assumed these may be higher and done by special levies.</p>			
Scope of Work	<p>Remove all landscaping features, planters, pavers, hardscape, and other overburden materials above the courtyard slab. Lift and dispose of existing XPS insulation panels as appropriate. Remove the existing bituminous membrane system completely, exposing the structural slab. Inspect, repair, & patch the underlying concrete slab & reinforcing steel as needed. Prime and detail the slab surface per specifications; install new reinforced bituminous membrane using hot-mopped and flood-coated methods.</p>			
Potential Deterioration	<p>Membrane Aging: Loss of elasticity and cracking due to thermal cycling and natural aging, blistering and bubbling caused by trapped moisture. Prompt Repairs: Address localized damage quickly, such as minor splits or punctures, to prevent systemic water intrusion—can often be done by lifting overburden in targeted zones.</p>			
Suggested Maintenance	<p>Conduct annual inspections, especially after winter, to check for signs of cracking, blistering, seam separation, or water damage. Monitor Landscaping watching for root intrusion from planters and landscaping, and ensure ongoing inspections of transition details at upstands</p>

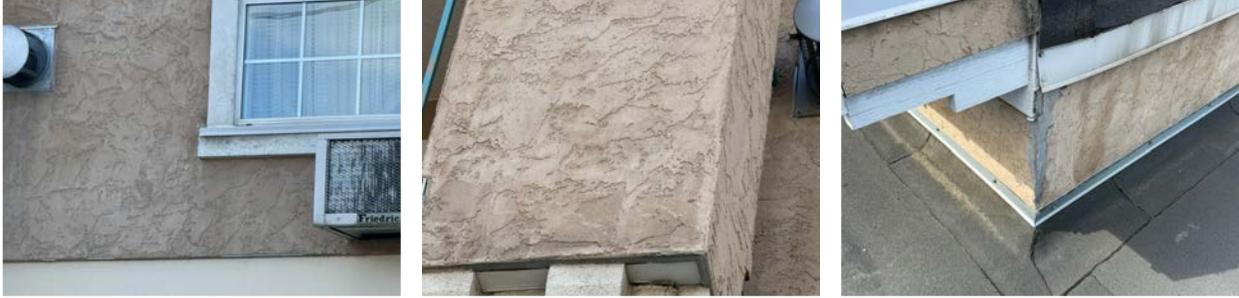
<table border="0" style="width: 100%; text-align: center;"> <tr> <td style="width: 33%;"> Estimated Current Cost \$321,600 Budget 50% </td> <td style="width: 33%;"> Projected Replacement Cost \$546,600 Due in 2040 </td> <td style="width: 33%;"> Effective Age / Lifespan (years) 25 / 40 </td> </tr> </table>		Estimated Current Cost \$321,600 Budget 50%	Projected Replacement Cost \$546,600 Due in 2040	Effective Age / Lifespan (years) 25 / 40
Estimated Current Cost \$321,600 Budget 50%	Projected Replacement Cost \$546,600 Due in 2040	Effective Age / Lifespan (years) 25 / 40		
Description	This component accounts for the stucco siding envelope system. This system includes the building frame, sheathing, building paper, insulation, and stucco siding.			
Condition Analysis	Based on a partial visual inspection, this component appears to be in average condition for its age. No major deficiencies were noted or reported at the time of inspection.			
Work Completed	In 2021 the owners authorized the expenditure of up to \$ 24,952.00 from the contingency reserve fund to complete planned capital projects, which include, new carpet on the landings and stairways, stucco repair and caulking on the exterior of the building and resurfacing deck membranes (maximum of three), painting of fascia, soffits and pergolas.			
Scope of Work	Remove and dispose of all or damaged stucco. Repair damaged building frame and sheathing. Replace building paper and insulation as needed. Install new stucco system, work-site clean up, and any special safety preparation and precautions as required.			
Potential Deterioration	Includes cracking, splitting, and water ingress caused by environmental factors such as extreme temperature changes, rain, snow, wind, and sun exposure. Contributing factors include physical damage, debris accumulation, moss, algae, and mold.			
Suggested Maintenance	Regular visual inspection of siding for impact damage, cracking, water ingress, debris build up, and environmental damages. Patch work, paint, clean, and caulk as required.

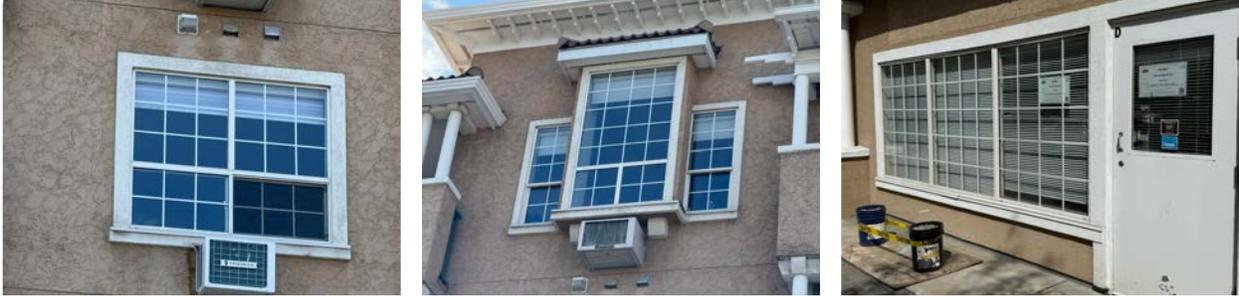
<p>Estimated Current Cost \$222,600 Budget 50%</p>	<p>Projected Replacement Cost \$378,400 Due in 2040</p>	<p>Effective Age / Lifespan (years) 25 / 40</p>
Description	<p>This component accounts for the exterior aluminum-frame windows. This includes the frame, hardware, casing, and aluminum windows.</p>	
Condition Analysis	<p>Based on a partial visual inspection, this component appears to be in average condition for its age. No major deficiencies were noted or reported at the time of inspection.</p>	
Work Completed	<p>Unknown total scope of reserve fund work completed to date.</p>	
Scope of Work	<p>Remove and dispose of damaged window assemblies, repairs to or replacement of the frame, casing, and hardware as required, and installation of new windows. Appropriate safety preparation and precautions as required.</p>	
Potential Deterioration	<p>Includes impact damage, failure or deterioration of the seals, failure of the opening mechanism, and wear-and-tear. Contributing factors include physical damage, seal deterioration, failed caulking, and environmental factors such as extreme temperature changes, rain, snow, wind, and sun exposure. Failure of the seals can cause fogging and moisture on the inner panes of the window.</p>

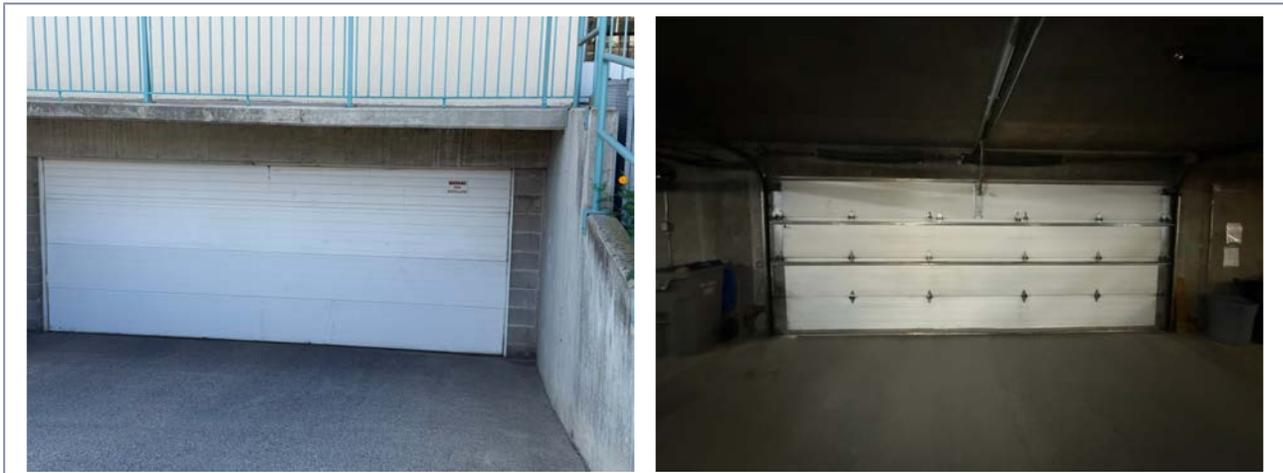
Estimated Current Cost	Projected Replacement Cost	Effective Age / Lifespan (years)
<p style="text-align: center;">\$13,600</p>	<p style="text-align: center;">\$26,600 Due in 2022</p>	<p style="text-align: center;">25 / 22</p>
<p>Description</p>	<p>This component accounts for the parkade's entrance gate. This excludes the remote openers but includes the gate, operating mechanism, tracks, rollers, and associated hardware.</p>	
<p>Condition Analysis</p>	<p>Based on a partial visual inspection, this component appears to be in average condition for its age. No major deficiencies were noted or reported at the time of inspection.</p>	
<p>Work Completed</p>	<p>Unknown total scope of reserve fund work completed to date.</p>	
<p>Scope of Work</p>	<p>Remove and replace damaged or failed door components as required.</p>	
<p>Potential Deterioration</p>	<p>Includes impact damage, wear-and-tear, electronic failure, mechanical failure, and water damage. Contributing factors include physical damage, debris accumulation, subsurface shifting, and damage from environmental factors such as extreme temperature changes, rain, snow, wind, and sun exposure.</p>

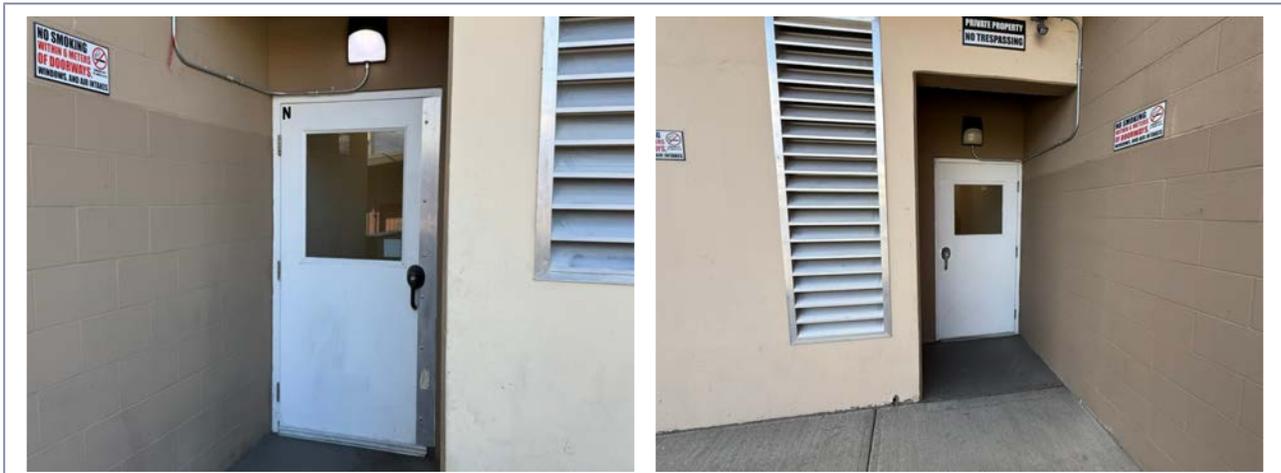
Estimated Current Cost	Projected Replacement Cost	Effective Age / Lifespan (years)
	\$19,300 Budget 25%	\$23,000 Due in 2030	25 / 30
Description	This component accounts for the common-element exterior metal doors. This includes the doors and all associated hardware.		
Condition Analysis	Based on a partial visual inspection, this component appears to be in average condition for its age. No major deficiencies were noted or reported at the time of inspection.		
Work Completed	Unknown total scope of reserve fund work completed to date.		
Scope of Work	Remove and replace damaged door system components as required or desired.		
Potential Deterioration	Includes impact damage, misalignment, failure to latch, corrosion, fading, warping, and other aesthetic degradation. Contributing factors include excessive force, wear-and-tear, physical damage, subsurface shifting, and environmental factors such as extreme temperature changes, rain, snow, wind, and sun exposure.

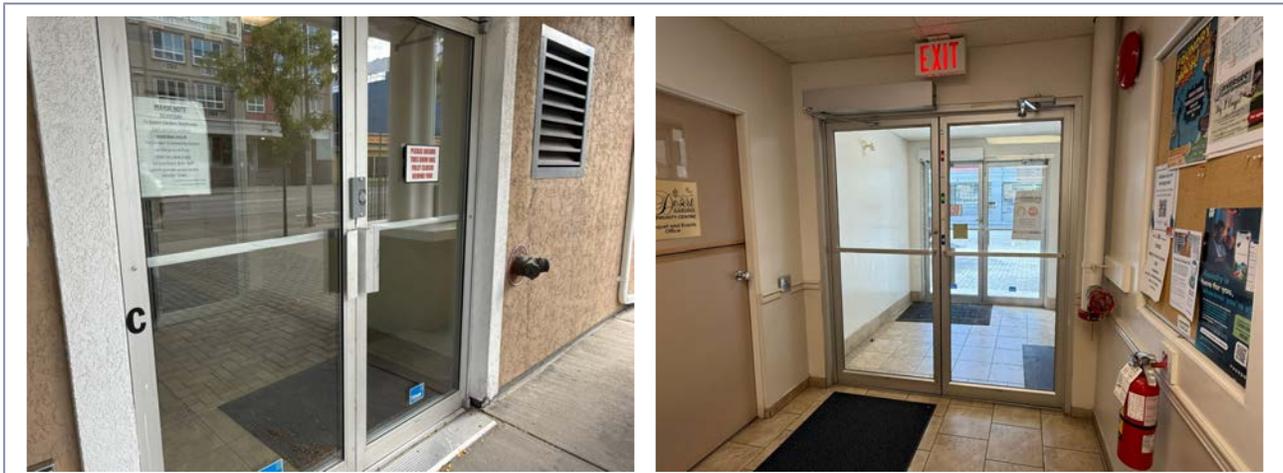
#7 / Structural and Architectural / Exterior Metal and Glass Doors

Estimated Current Cost \$16,200 Budget 33%	Projected Replacement Cost \$19,300 Due in 2030	Effective Age / Lifespan (years) 20 / 25
--	---	---

Description	This component accounts for the common-element exterior metal-and-glass doors. This includes the doors, glass lites, frames, and all associated hardware.
Condition Analysis	Based on a partial visual inspection, this component appears to be in average condition for its age. No major deficiencies were noted or reported at the time of inspection.
Work Completed	Unknown total scope of reserve fund work completed to date.
Scope of Work	Remove and replace damaged door system components as required or desired.
Potential Deterioration	Includes impact damage, glass breakage, seal failure, misalignment, failure to latch, corrosion, fading, warping, and other aesthetic degradation. Contributing factors include wear-and-tear, physical damage, excessive force, subsurface shifting, and environmental factors such as extreme temperature changes, rain, snow, wind, and sun exposure.
Suggested Maintenance	Regular visual inspection of the door and hardware. Clean and seal/paint as required.

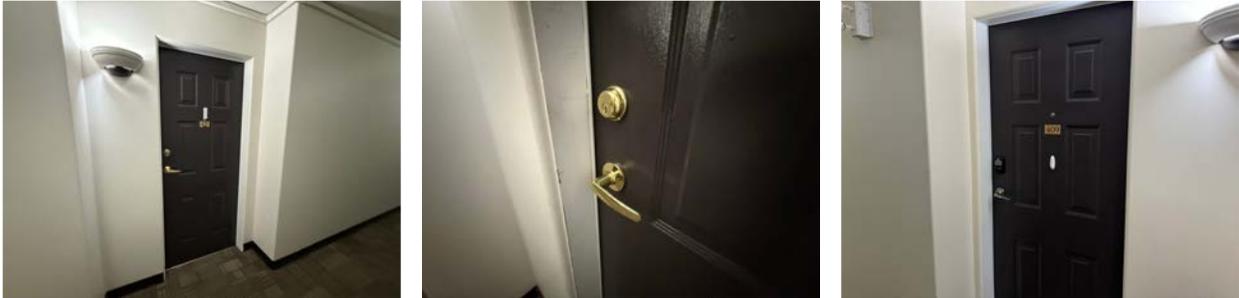
<p>Estimated Current Cost \$36,800 Budget 33%</p>	<p>Projected Replacement Cost \$52,500 Due in 2035</p>	<p>Effective Age / Lifespan (years) 25 / 35</p>
Description	This component accounts for the common-element interior wooden doors. This includes the doors, frames, and all associated hardware.	
Condition Analysis	Based on a partial visual inspection, this component appears to be in average condition for its age. No major deficiencies were noted or reported at the time of inspection.	
Work Completed	Unknown total scope of reserve fund work completed to date.	
Scope of Work	Remove and replace damaged door system components as required or desired.	
Potential Deterioration	Includes impact damage, misalignment, failure to latch, and aesthetic degradation. Contributing factors include wear-and-tear, physical damage, excessive force, and subsurface shifting.	
Suggested Maintenance	Regular visual inspection of the door and hardware. Clean and paint as required.

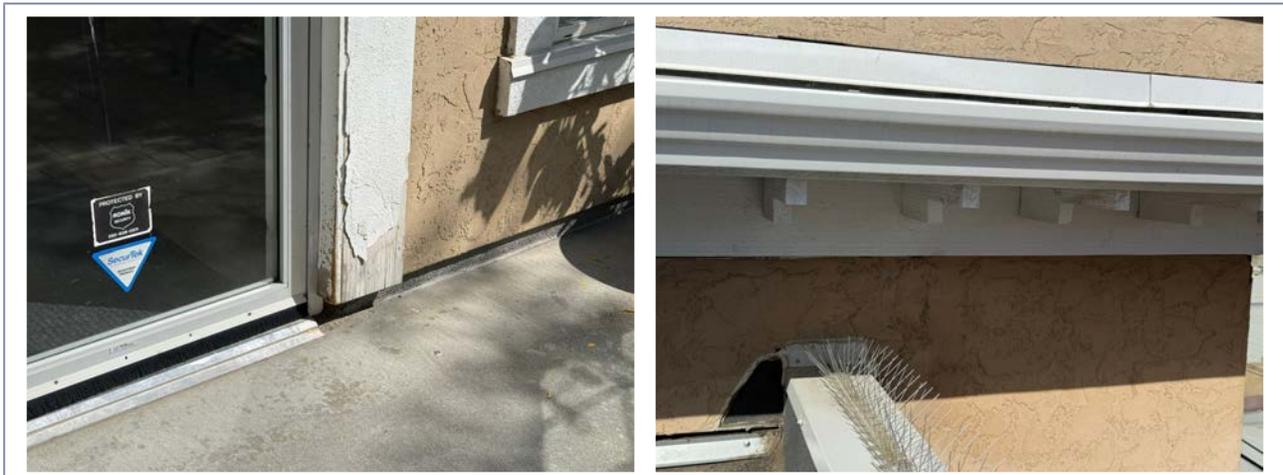
#11 / Structural and Architectural / Wood Fascia and Trim

Estimated Current Cost \$17,400 Budget 50%	Projected Replacement Cost \$20,800 Due in 2030	Effective Age / Lifespan (years) 20 / 25
--	---	---

Description	This component accounts for the common-element wooden fascia board and trim.
Condition Analysis	Based on a partial visual inspection, this component appears to be in average condition for its age. No major deficiencies were noted or reported at the time of inspection.
Work Completed	In 2021 the owners authorized the expenditure of up to \$ 24,952.00 from the contingency reserve fund to complete planned capital projects, which include, new carpet on the landings and stairways, stucco repair and caulking on the exterior of the building and resurfacing deck membranes (maximum of three), painting of fascia, soffits and pergolas.
Scope of Work	Remove and replace damaged elements as required or desired. Appropriate safety preparation and precautions as required.
Potential Deterioration	Includes impact damage, water damage, and deterioration. Contributing factors include physical damage, insufficient paint and caulking, and environmental factors such as extreme temperature changes, rain, snow, wind, and sun exposure.

Suggested Maintenance	Regular visual inspection. Clean, paint, and caulk as required.

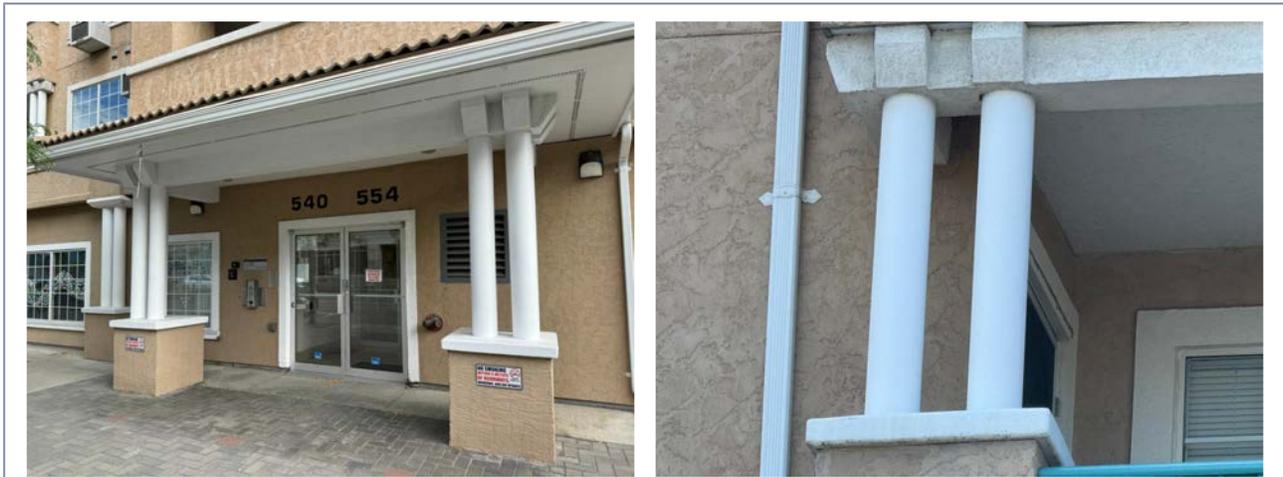
#12 / Structural and Architectural / Post Supports

Estimated Current Cost \$22,800 Budget 50%	Projected Replacement Cost \$55,100 Due in 2050	Effective Age / Lifespan (years) 25 / 50
--	---	---

Description	This component accounts for the common-element structural wooden posts.
Condition Analysis	Based on a partial visual inspection, this component appears to be in average condition for its age. No major deficiencies were noted or reported at the time of inspection.
Work Completed	Unknown total scope of reserve fund work completed to date.
Scope of Work	Remove and replace damaged elements as required or desired. Temporary shoring as required. Appropriate safety preparation and precautions as required.
Potential Deterioration	Includes impact damage, water damage, and deterioration. Contributing factors include physical damage, insufficient sealing, and environmental factors such as extreme temperature changes, rain, snow, wind, and sun exposure.
Suggested Maintenance	Regular visual inspection. Clean and re-seal as required.

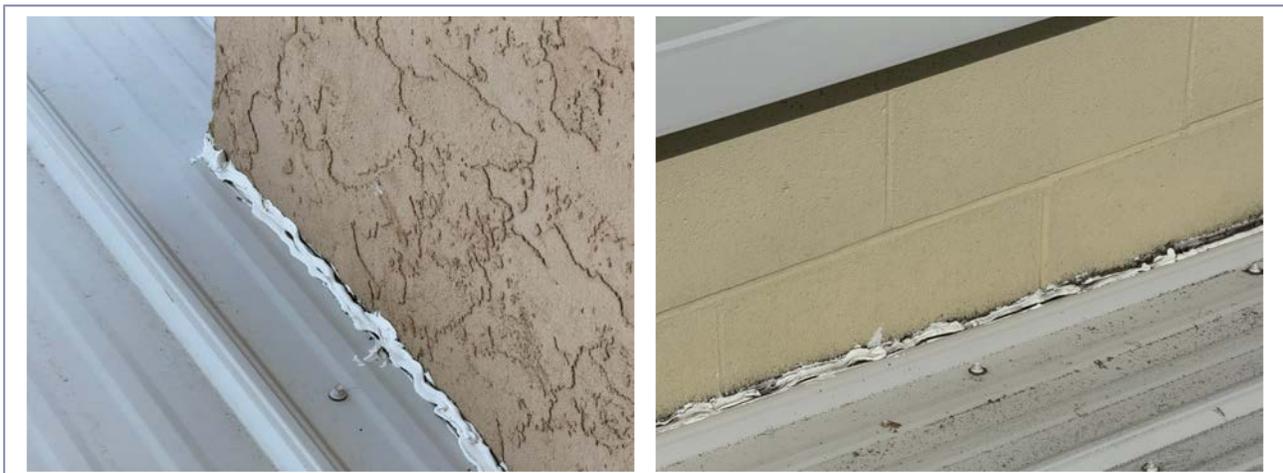
#13 / Structural and Architectural / Caulking

Estimated Current Cost \$12,900 Budget 50%	Projected Replacement Cost \$13,800 Due in 2027	Effective Age / Lifespan (years) 10 / 12
--	---	---

Description	This component accounts for the common-element caulking found around the windows, exterior doors, and some trim.
Condition Analysis	Based on a partial visual inspection, this component appears to be in average condition for its age. No major deficiencies were noted or reported at the time of inspection.
Work Completed	In 2021 the owners authorized the expenditure of up to \$ 24,952.00 from the contingency reserve fund to complete planned capital projects, which include, new carpet on the landings and stairways, stucco repair and caulking on the exterior of the building and resurfacing deck membranes (maximum of three), painting of fascia, soffits and pergolas.
Scope of Work	Remove and replace failed caulking as required. Appropriate safety preparation and precautions as required.
Potential Deterioration	Includes hardening, cracking, shrinking, and powdering of the caulking surface. Contributing factors include environmental factors such as temperature changes, rain, snow, wind, and sun exposure.

Suggested Maintenance	Regular visual and tactile inspection of the exterior caulking. Replace as required.

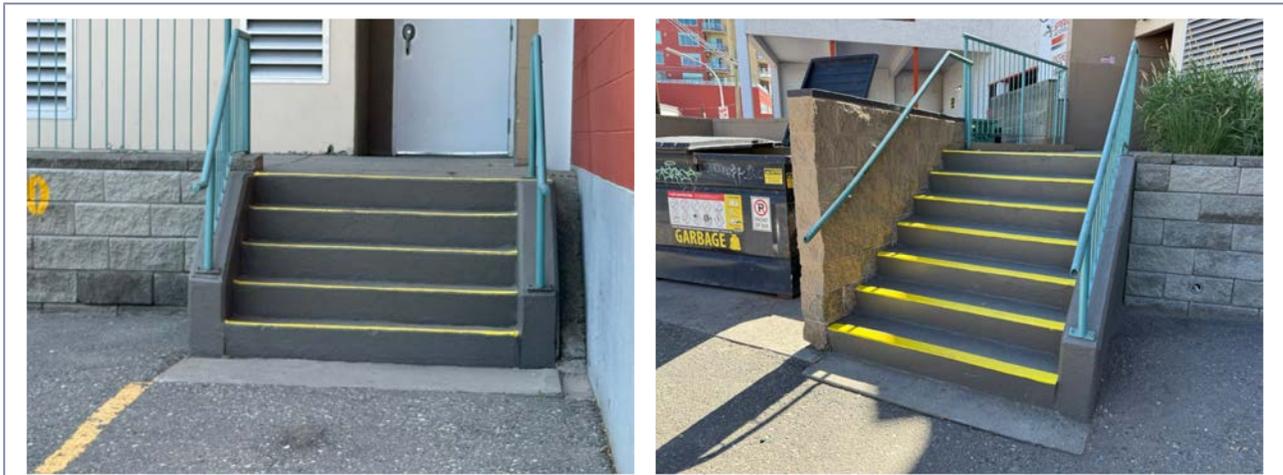
#14 / Structural and Architectural / Concrete Stairs

Estimated Current Cost \$5,400 Budget 25%	Projected Replacement Cost \$31,500 Due in 2075	Effective Age / Lifespan (years) 25 / 75
---	---	---

Description	This component accounts for the common-element concrete stairs and landings.
Condition Analysis	Based on a partial visual inspection, this component appears to be in average condition for its age. No major deficiencies were noted or reported at the time of inspection.
Work Completed	Unknown total scope of reserve fund work completed to date.
Scope of Work	Break and remove concrete stairs. Repair the subgrade. Form and pour concrete.
Potential Deterioration	Includes holes, cracking, spalling, delamination, slab movement, poor grading, ponding water, and expansion joint failure. Contributing factors include impact damage, wear-and-tear, debris accumulation, subsurface shifting, and environmental factors such as temperature changes, rain, snow, wind, and sun exposure.
Suggested Maintenance	Regular inspection of the stairs for deterioration and shifting. Inspect, clean, and repair as required.

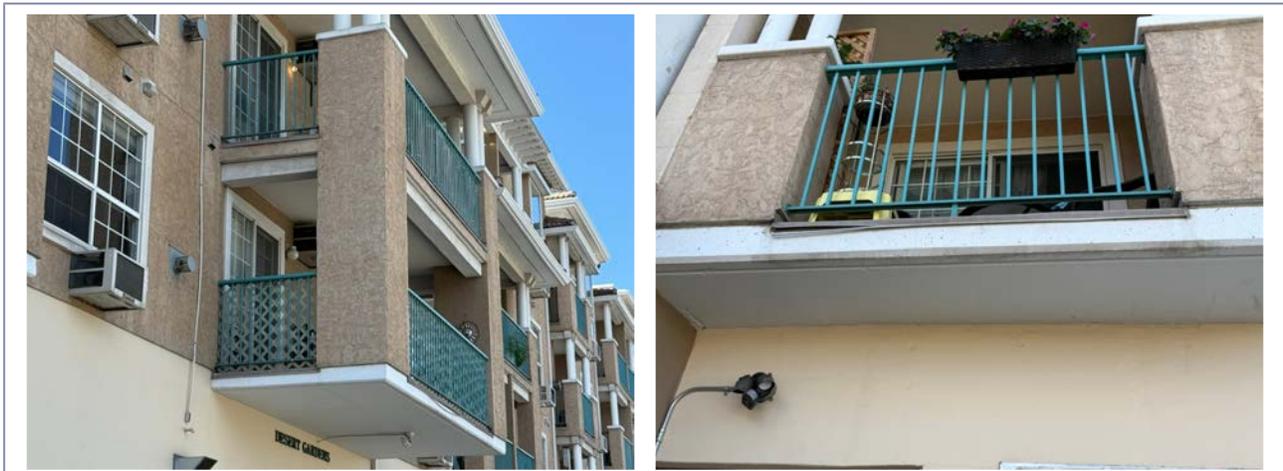
Estimated Current Cost \$71,000 Budget 25%	Projected Replacement Cost \$120,700 Due in 2040	Effective Age / Lifespan (years) 25 / 40
Description	This component accounts for the common-element balcony structures. The cost reflects periodic repairs rather than a large-scale demo and rebuild.		
Condition Analysis	Based on a partial visual inspection, this component appears to be in average condition for its age. No major deficiencies were noted or reported at the time of inspection.		
Work Completed	Unknown total scope of reserve fund work completed to date.		
Scope of Work	Sounding, marking, cutting, an allowance for removing concrete to expose small amounts of corroded rebar, reinforcing, bonding the rebar, placing concrete, consolidating, screeding, floating, finishing, and spraying a curing compound. Appropriate safety preparation and precautions as required.		
Potential Deterioration	Includes impact damage, cracking, spalling, rebar corrosion, and water damage. Contributing factors include physical damage, subsurface shifting, debris accumulation, and environmental factors such as extreme temperature changes, rain, snow, wind, and sun exposure.

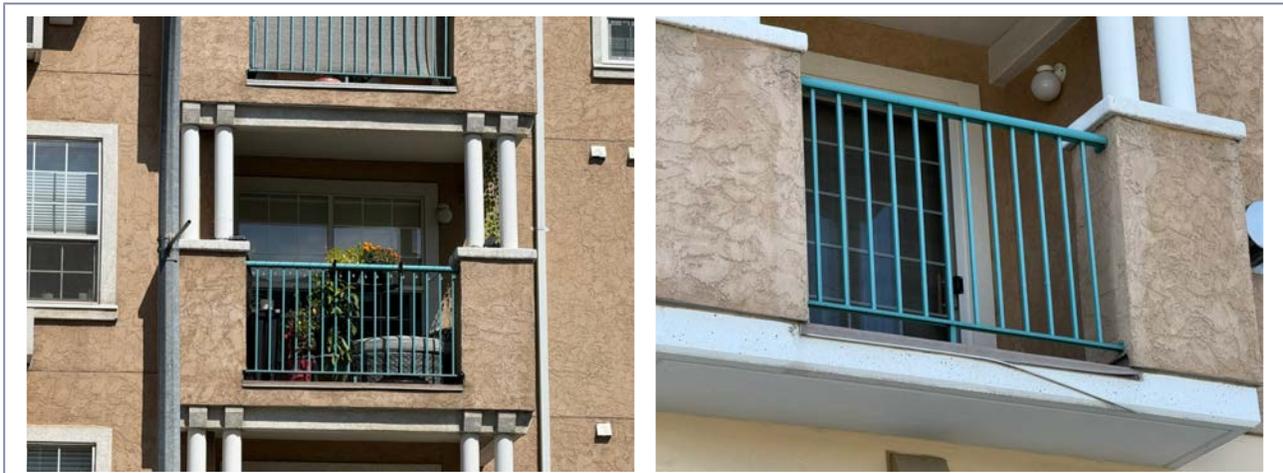
Estimated Current Cost \$108,500 Budget 50%	Projected Replacement Cost \$154,600 Due in 2035	Effective Age / Lifespan (years) 25 / 35
Description	This component accounts for the metal railing systems, including all associated fasteners and hardware.	
Condition Analysis	Based on a partial visual inspection, this component appears to be in average condition for its age. No major deficiencies were noted or reported at the time of inspection.	
Work Completed	Unknown total scope of reserve fund work completed to date.	
Scope of Work	Remove and replace failed railings. Appropriate safety preparation and precautions as required.	
Potential Deterioration	Includes breakage, water damage, loosening of fasteners, wear-and-tear, and aesthetic degradation. Contributing factors include physical damage, debris accumulation, and environmental factors such as extreme temperature changes, rain, snow, wind, and sun exposure.

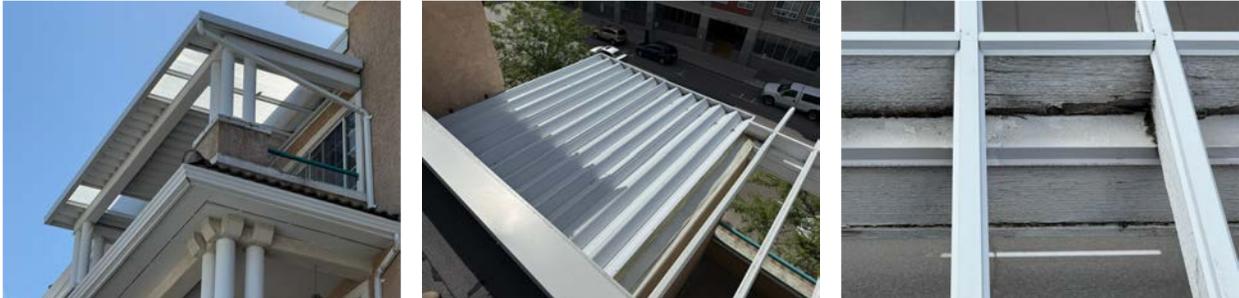
<p>Estimated Current Cost \$16,000 Budget 25%</p>	<p>Projected Replacement Cost \$22,800 Due in 2035</p>	<p>Effective Age / Lifespan (years) 25 / 35</p>
Description	This component accounts for the canopy system. This includes the canopy, frame, and associated hardware.	
Condition Analysis	Based on a partial visual inspection, this component appears to be in average condition for its age. No major deficiencies were noted or reported at the time of inspection.	
Work Completed	Unknown total scope of reserve fund work completed to date.	
Scope of Work	Remove and replace existing canopy assembly.	
Potential Deterioration	Includes impact damage, fading, corrosion, fastener failure, and water damage. Contributing factors include physical damage, debris accumulation, and environmental factors such as extreme temperature changes, rain, snow, wind, and sun exposure.	
Suggested Maintenance	Regular visual inspection for impact damage, corrosion, and fastener deterioration. Clean, seal/paint, and repair as required.

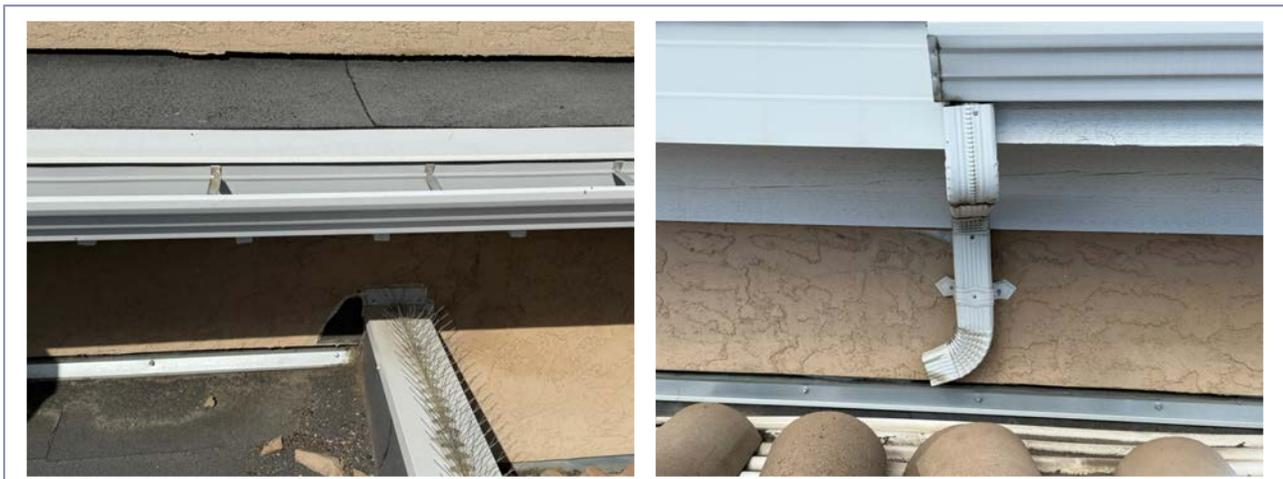
#19 / Structural and Architectural / Gutters and Downspouts

Estimated Current Cost \$5,000 Budget 30%	Projected Replacement Cost \$5,900 Due in 2030	Effective Age / Lifespan (years) 25 / 30
---	--	---

Description	This component accounts for the gutters (also referred to as "eavestroughs") and the downspouts.
Condition Analysis	Based on a partial visual inspection, this component appears to be in average condition for its age. No major deficiencies were noted or reported at the time of inspection.
Work Completed	Unknown total scope of reserve fund work completed to date.
Scope of Work	Remove and replace damaged gutters and downspouts as required. Appropriate safety preparation and precautions as required.
Potential Deterioration	Includes impact damage, seal failure, warping, and deterioration. Contributing factors include physical damage and environmental factors such as extreme temperature changes, rain, snow, wind, and sun exposure.
Suggested Maintenance	Regular visual inspection. Clean, seal, and caulk as required.

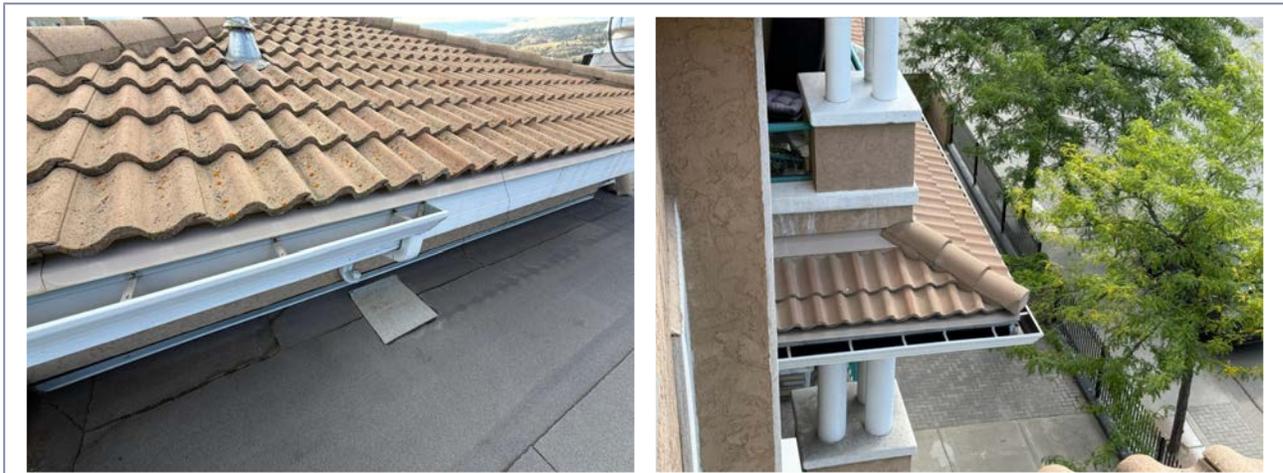
Estimated Current Cost	Projected Replacement Cost	Effective Age / Lifespan (years)
	\$15,200 Budget 25%	\$18,200 Due in 2030	25 / 30
Description	This component accounts for the tile roofing system. This includes the tile, underlayment, and an allowance for replacement of damaged sheathing and roof-openings such as vents.		
Condition Analysis	Based on a partial visual inspection, this component appears to be in average condition for its age. No major deficiencies were noted or reported at the time of inspection.		
Work Completed	Unknown total scope of reserve fund work completed to date.		
Scope of Work	Remove and replace damaged roofing components as required. Appropriate safety preparation and precautions as required.		
Potential Deterioration	Includes chipping, cracking, breaking, moss, and wear-and-tear. Contributing factors include physical damage, pressure-washing, debris accumulation, and environmental factors such as extreme temperature changes, rain, snow, wind, and sun exposure.

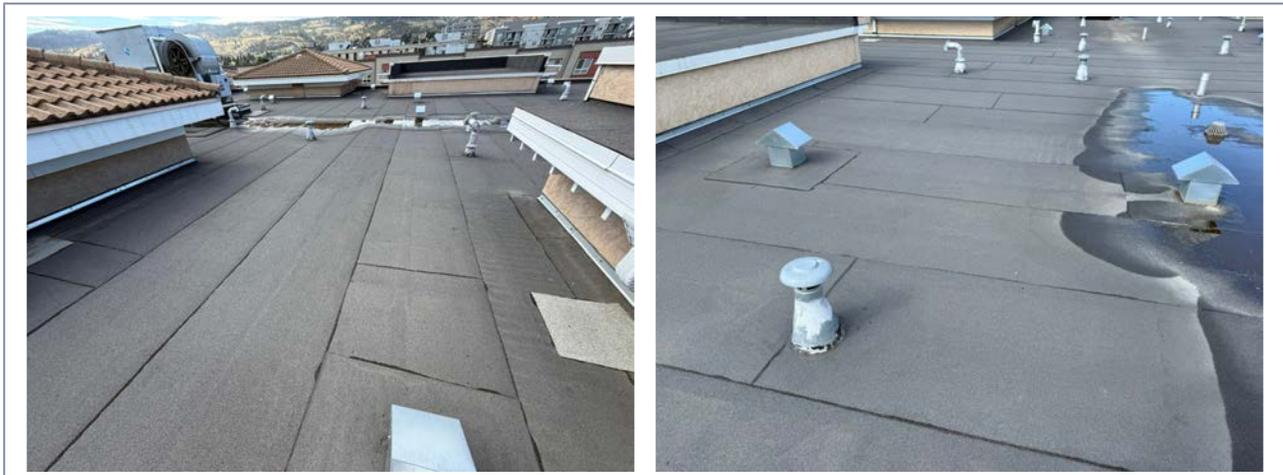
Estimated Current Cost \$218,400	Projected Replacement Cost \$234,400 Due in 2027	Effective Age / Lifespan (years) 20 / 22
Description	This component accounts for the two-ply membrane roofing system. This includes the membrane, insulation, flashing, and an allowance for replacement of roof-openings such as vents.		
Condition Analysis	Based on a partial visual inspection, this component appears to be in average condition for its age. No major deficiencies were noted or reported at the time of inspection.		
Work Completed	Unknown total scope of reserve fund work completed to date.		
Scope of Work	Remove and replace existing roofing assembly. Appropriate safety preparation and precautions as required.		
Potential Deterioration	Includes punctures, impact damage, water damage, cracking, bubbling, and wear-and-tear. Contributing factors include physical damage, debris accumulation, and environmental factors such as extreme temperature changes, rain, snow, wind, and sun exposure.

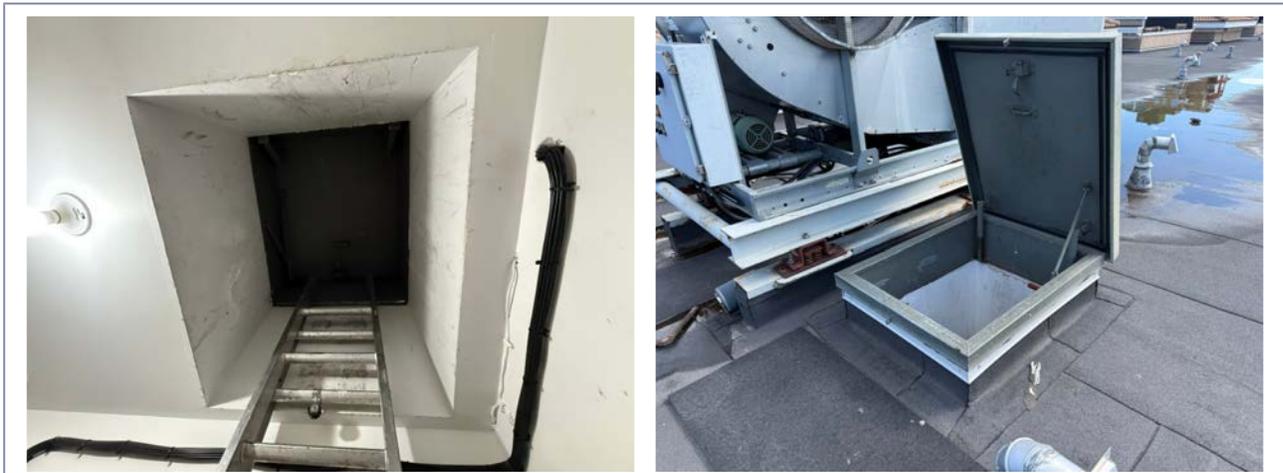
#22 / Structural and Architectural / Roof Access Hatch

Estimated Current Cost \$1,400 Budget 30%	Projected Replacement Cost \$1,600 Due in 2030	Effective Age / Lifespan (years) 25 / 30
--	---	--

Description	This component accounts for the roof access hatch. This includes the cover, hatch, curb, and insulation.
Condition Analysis	Based on a partial visual inspection, this component appears to be in average condition for its age. No major deficiencies were noted or reported at the time of inspection.
Work Completed	Unknown total scope of reserve fund work completed to date.
Scope of Work	Remove and replace existing hatch assembly. Appropriate safety preparation and precautions as required.
Potential Deterioration	Includes impact damage, corrosion, seal/curb deterioration, hinge/spring deterioration, opening-mechanism failure, and water damage. Contributing factors include physical damage, wear-and-tear, and environmental factors such as extreme temperature changes, rain, snow, wind, and sun exposure.
Suggested Maintenance	Regular visual inspection for leaks, corrosion, and mechanism deterioration. Clean, tighten, lubricate, and repair as required.

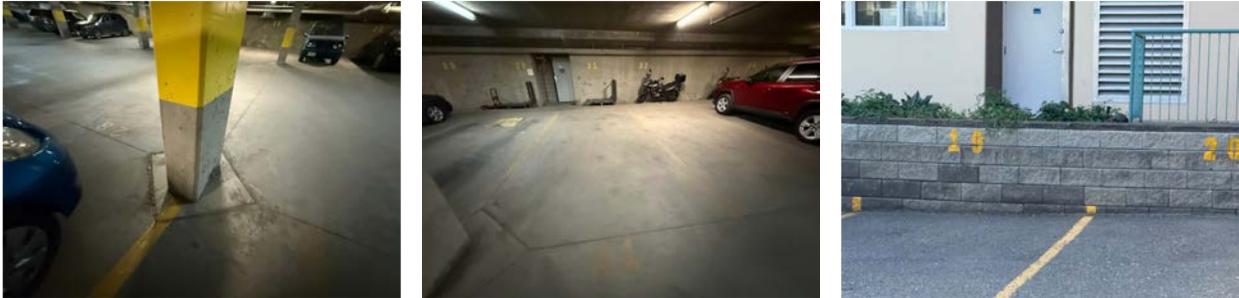
<table border="0" style="width: 100%; text-align: center;"> <tr> <td style="width: 33%;"> <p>Estimated Current Cost</p> <p>\$3,800</p> </td> <td style="width: 33%;"> <p>Projected Replacement Cost</p> <p>\$4,300</p> <p>Due in 2029</p> </td> <td style="width: 33%;"> <p>Effective Age / Lifespan (years)</p> <p>4 / 8</p> </td> </tr> </table>		<p>Estimated Current Cost</p> <p>\$3,800</p>	<p>Projected Replacement Cost</p> <p>\$4,300</p> <p>Due in 2029</p>	<p>Effective Age / Lifespan (years)</p> <p>4 / 8</p>
<p>Estimated Current Cost</p> <p>\$3,800</p>	<p>Projected Replacement Cost</p> <p>\$4,300</p> <p>Due in 2029</p>	<p>Effective Age / Lifespan (years)</p> <p>4 / 8</p>		
Description	This component accounts for the common-element pavement markings.			
Condition Analysis	Based on a visual inspection, this component appears to be in average condition for its age. No major deficiencies were noted or reported at the time of inspection.			
Work Completed	Unknown total scope of reserve fund work completed to date.			
Scope of Work	Repaint existing markings as required or desired.			
Potential Deterioration	Includes chipping, fading, and obfuscation. Contributing factors include wear-and-tear, impact damage, debris accumulation, chemical damage (particularly from de-icing chemicals), and environmental factors such as temperature changes, rain, snow, wind, and sun exposure.			
Suggested Maintenance	Regular inspection of the markings for visibility. Inspect, clean, and repaint as required.

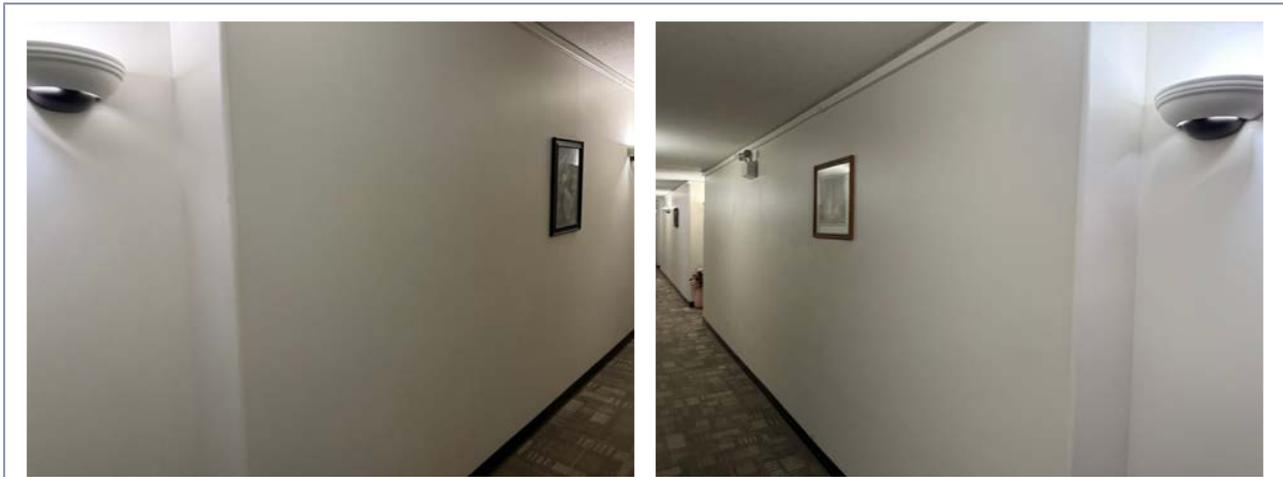
#26 / Building - Finishes and Decoration / Interior Paint

Estimated Current Cost \$78,300	Projected Replacement Cost \$96,800 Due in 2031	Effective Age / Lifespan (years) 10 / 16
---	--	--

Description	This component accounts for the interior paint finish in common areas.
Condition Analysis	Based on a visual inspection, this component appears to be in average condition for its age. No major deficiencies were noted or reported at the time of inspection.
Work Completed	Unknown total scope of reserve fund work completed to date.
Scope of Work	Surface preparation, painting, and clean-up.
Potential Deterioration	Includes impact damage, stains, markings, fading, and water damage. Contributing factors include physical damage, wear-and-tear, and environmental factors such as temperature changes, humidity, and sun exposure. Painting may also be done for aesthetic reasons.
Suggested Maintenance	Regular visual inspection for aesthetic quality. Clean, touch-up, and repaint as required or desired.

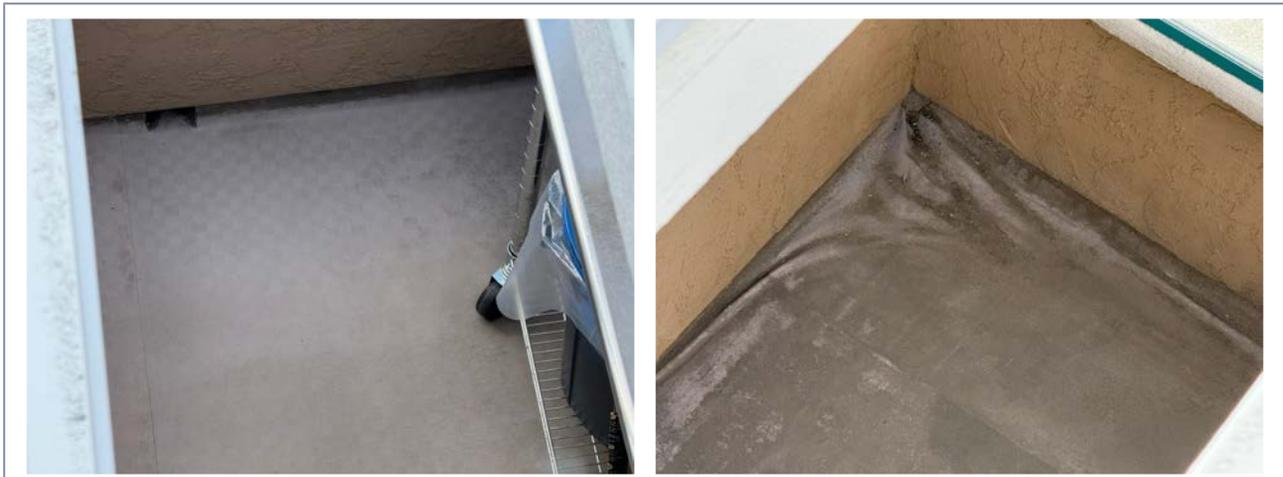
#27 / Building - Finishes and Decoration / Balcony Waterproofing

Estimated Current Cost \$54,700	Projected Replacement Cost \$92,900 Due in 2040	Effective Age / Lifespan (years) 0 / 15
---	--	---

Description	This component accounts for the balcony waterproofing membrane.
Condition Analysis	Based on a partial visual inspection, this component appears to be in average condition for its age. No major deficiencies were noted or reported at the time of inspection.
Work Completed	Unknown total scope of reserve fund work completed to date.
Scope of Work	Remove old membrane. Prepare balcony surface. Re-install metal flashing. Install vinyl membrane with liquid adhesive and hot-air welding.
Potential Deterioration	Includes impact damage, delamination, fading, cracking, bubbling, wear-and-tear, and water damage. Contributing factors include physical damage, debris accumulation, and environmental factors such as extreme temperature changes, rain, snow, wind, and sun exposure.
Suggested Maintenance	Regular visual inspection for delamination, fading, cracking, bubbling, and water damage. Clean, patch, and repair as required.

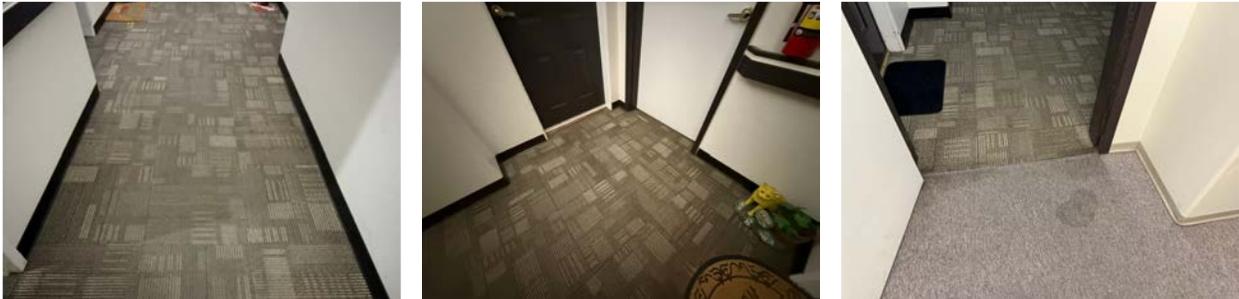
<table border="0" style="width: 100%; text-align: center;"> <tr> <td style="width: 33%;"> <p>Estimated Current Cost \$26,300</p> </td> <td style="width: 33%;"> <p>Projected Replacement Cost \$37,500 Due in 2035</p> </td> <td style="width: 33%;"> <p>Effective Age / Lifespan (years) 5 / 15</p> </td> </tr> </table>		<p>Estimated Current Cost \$26,300</p>	<p>Projected Replacement Cost \$37,500 Due in 2035</p>	<p>Effective Age / Lifespan (years) 5 / 15</p>
<p>Estimated Current Cost \$26,300</p>	<p>Projected Replacement Cost \$37,500 Due in 2035</p>	<p>Effective Age / Lifespan (years) 5 / 15</p>		
Description	This component accounts for the interior common-area carpet flooring.			
Condition Analysis	Based on a visual inspection, this component appears to be in average condition for its age. No major deficiencies were noted or reported at the time of inspection.			
Work Completed	In 2021 the owners authorized the expenditure of up to \$ 24,952.00 from the contingency reserve fund to complete planned capital projects, which include, new carpet on the landings and stairways, stucco repair and caulking on the exterior of the building and resurfacing deck membranes (maximum of three), painting of fascia, soffits and pergolas.			
Scope of Work	Remove and replace the damaged carpet or the entire carpet, including the carpet pad, depending on the extent and cause of the damage.			
Potential Deterioration	Includes fading, matting, colour-loss, wear-and-tear, wrinkles, ripples, stains, burns, strong odors, and lack of padding support. Contributing factors include physical damage, water damage, spills, debris accumulation, and damage from environmental factors such as temperature changes, humidity, and sun exposure. Carpet may also be replaced for aesthetic reasons.			
Suggested Maintenance	Regular inspection of the carpet for deterioration and odors. Vacuum, clean, and repair as required.

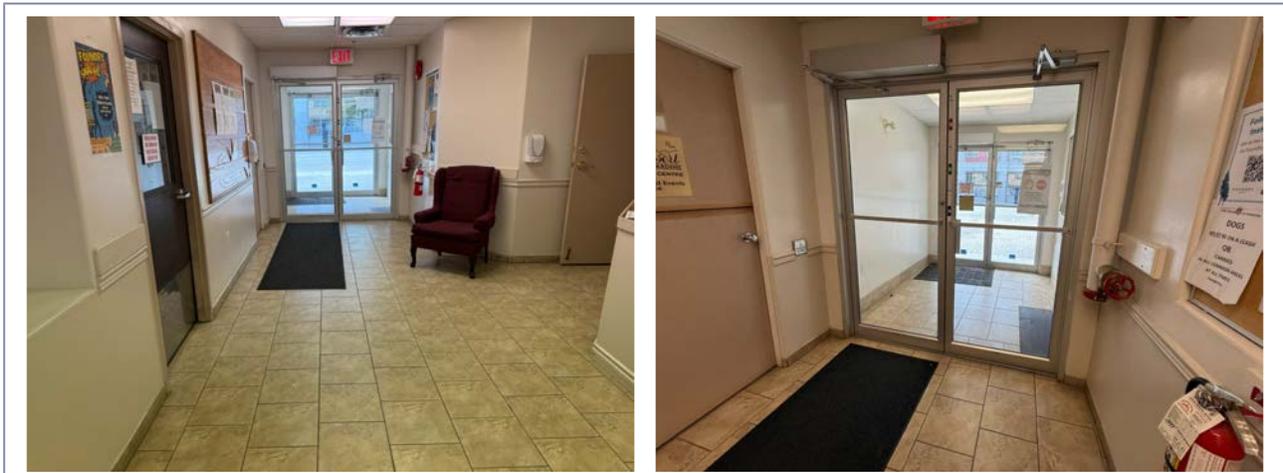
Estimated Current Cost \$3,400 Budget 75%	Projected Replacement Cost \$4,100 Due in 2030	Effective Age / Lifespan (years) 10 / 15
Description	This component accounts for periodic renovations to the common-area lobby. This includes the flooring, lighting, finish, furniture, and décor.		
Condition Analysis	Based on a visual inspection, this component appears to be in average condition for its age. No major deficiencies were noted or reported at the time of inspection.		
Work Completed	Unknown total scope of reserve fund work completed to date.		
Scope of Work	Renovate the lobby components as desired.		
Potential Deterioration	Includes impact damage, water damage, wear-and-tear, aesthetic degradation, discoloration, stains, and fading. Contributing factors include physical damage, debris accumulation, changing preferences, and damage from environmental factors such as temperature changes, humidity, and sun exposure.

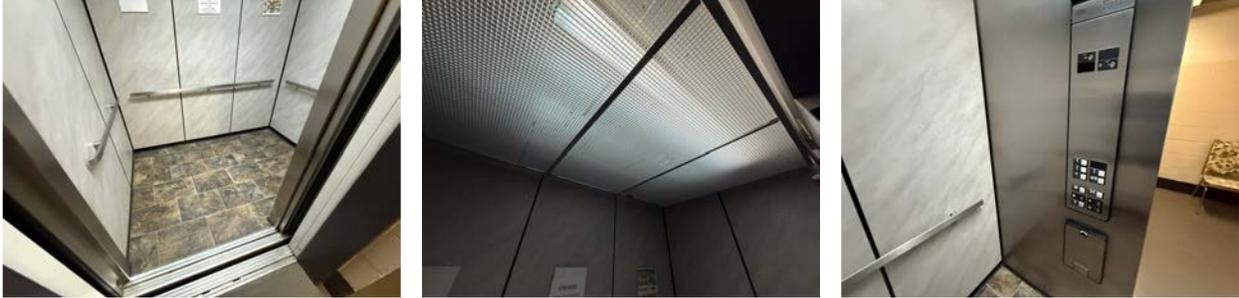
Estimated Current Cost \$25,500	Projected Replacement Cost \$27,300 Due in 2027	Effective Age / Lifespan (years) 20 / 22
Description	This component accounts for periodic renovations to the interior of the elevator cabs. This includes the flooring, wall panels, ceiling, lighting, and railings. This component does not include safety features or mechanical/electrical components within the elevator enclosure.	
Condition Analysis	Based on a visual inspection, this component appears to be in average condition for its age. No major deficiencies were noted or reported at the time of inspection.	
Work Completed	Unknown total scope of reserve fund work completed to date.	
Scope of Work	Renovate the elevator cab components as desired.	
Potential Deterioration	Includes impact damage, water damage, wear-and-tear, and aesthetic degradation. Contributing factors include physical damage (usually from moving items in and out), debris accumulation, changing preferences, and damage from environmental factors such as temperature changes and humidity.
