Depreciation Report | 2025

Desert Gardens
554 Seymour Street
Kamloops, BC

KAS 1911—Desert Gardens
554 Seymour Street
Kamloops, BC
V2C 2G9

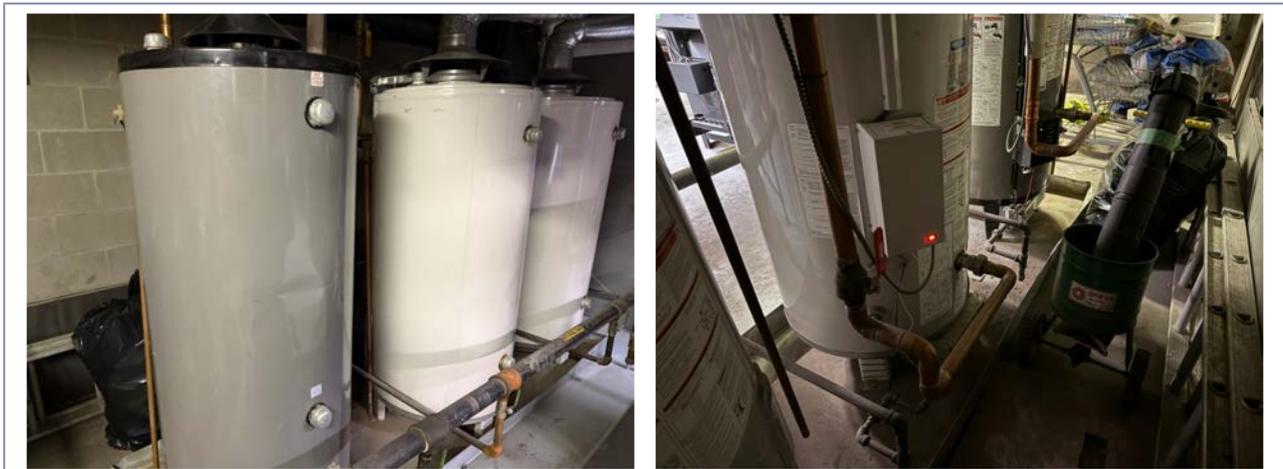
Estimated Current Cost \$16,200 Budget 45%		Projected Replacement Cost \$21,500 Due in 2033		Effective Age / Lifespan (years) 7 / 15
Description	This component accounts for the common-element water heaters. This includes the tanks, heating components, and controls. This excludes the piping, fittings, valves, and vents, which are accounted for separately in the Domestic Water Distribution component.			
Condition Analysis	Based on a partial visual inspection, this component appears to be in average condition for its age. No major deficiencies were noted or reported at the time of inspection.			
Work Completed	One heater was date stamped 09/2019, another 04/2014 and the third 02/2015.			
Scope of Work	Remove and replace the failing water heater.			
Potential Deterioration	Includes corrosion, leaks, heater failure, and decreased heating ability. Contributing factors include wear-and-tear, water corrosivity, mineral build-up, debris accumulation, overheating, insufficient maintenance, and environmental factors such as extreme temperatures and humidity.

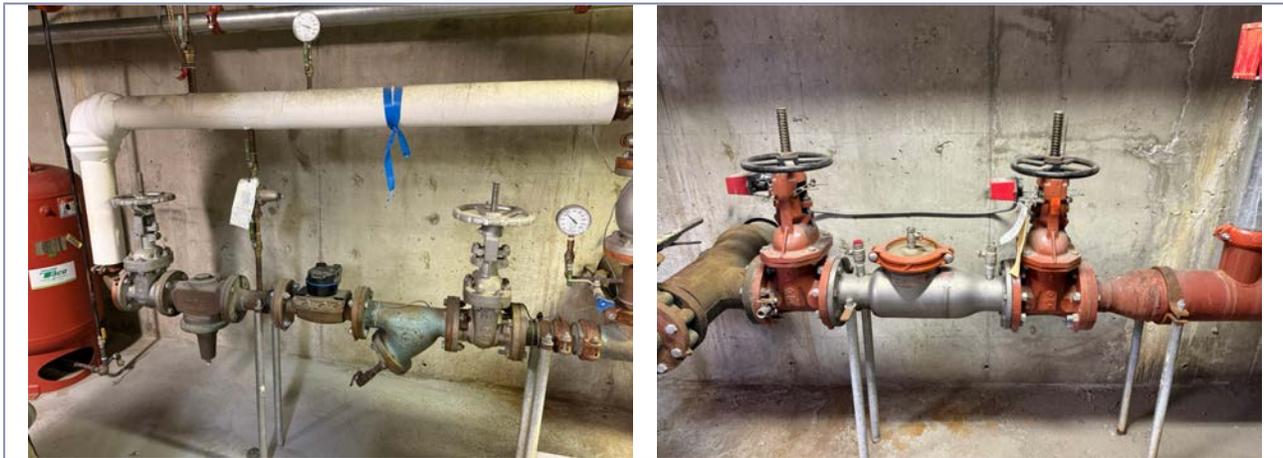
Estimated Current Cost \$201,500 Budget 25%	Projected Replacement Cost \$287,000 Due in 2035	Effective Age / Lifespan (years) 25 / 35
Description	This component accounts for the interior common-element domestic water distribution system. This includes risers, pumps, branch lines, valves, and backflow preventers for both the supply and removal of hot and cold water.		
Condition Analysis	We were not able to visually inspect this component. No major deficiencies were reported at the time of inspection, so we assume it to be in average condition for its age.		
Work Completed	Unknown total scope of reserve fund work completed to date.		
Scope of Work	Notify residents of work scope, disruption, and timeline. Access relevant areas while causing minimal damage. Replace damaged water supply components (usually with PEX) or, if water damage is frequent and severe, repipe most or all of the property to prevent further damage from occurring. Test system. Repair any damage and clean work areas.

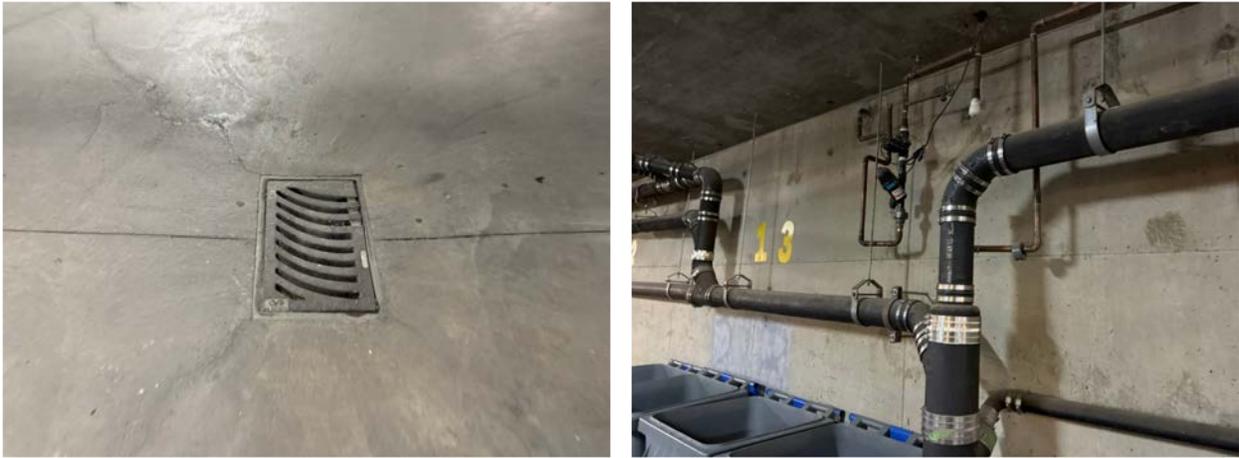
<table border="0" style="width: 100%; text-align: center;"> <tr> <td style="width: 33%;"> Estimated Current Cost \$21,200 Budget 25% </td> <td style="width: 33%;"> Projected Replacement Cost \$43,000 Due in 2045 </td> <td style="width: 33%;"> Effective Age / Lifespan (years) 25 / 45 </td> </tr> </table>		Estimated Current Cost \$21,200 Budget 25%	Projected Replacement Cost \$43,000 Due in 2045	Effective Age / Lifespan (years) 25 / 45
Estimated Current Cost \$21,200 Budget 25%	Projected Replacement Cost \$43,000 Due in 2045	Effective Age / Lifespan (years) 25 / 45		
Description	This component accounts for the subsurface common-element domestic water distribution system, both for the supply and removal of domestic water.			
Condition Analysis	We were not able to visually inspect this component. No major deficiencies were reported at the time of inspection, so we assume it to be in average condition for its age.			
Work Completed	Unknown total scope of reserve fund work completed to date.			
Scope of Work	Video inspection and internal cleaning, if possible. More significant damage will need the following: surface removal, excavation, damaged-pipe section removal, pipe bedding installation, pipe installation, backfill and compaction, and surface restoration.			
Potential Deterioration	Includes leaks, cracks, clogs, and connection failure. Contributing factors include impact damage, vibration and stress, debris accumulation, tree root damage, and environmental factors such as extreme temperatures.			
Suggested Maintenance	Regular inspection for leaks (unusually high water bill, pools, damp spots, low spots, dead grass/plants), low or inconsistent water pressure, and odors. Scope, flush, and repair as required.

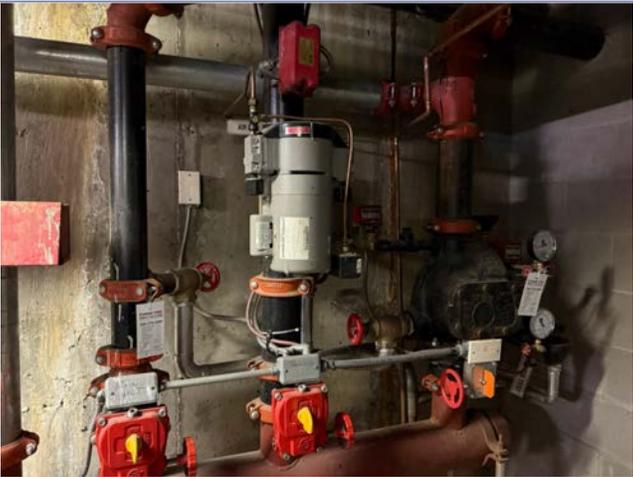
Estimated Current Cost \$125,900 Budget 20%	Projected Replacement Cost \$179,400 Due in 2035	Effective Age / Lifespan (years) 25 / 35
Description	This component accounts for the wet sprinkler system. This includes piping, pipe tees, valves, alarms, sprinkler heads, connections, and associated components.	
Condition Analysis	Based on a partial visual inspection, this component appears to be in average condition for its age. No major deficiencies were noted or reported at the time of inspection.	
Work Completed	Unknown total scope of reserve fund work completed to date.	
Scope of Work	Inspect and test system regularly to comply with local regulations. Do all work as required or recommended by the inspector. Remove and replace failing components.	
Potential Deterioration	Includes corrosion, pipe leaks and bursts, connection failure, and mechanical failure. Contributing factors include impact damage, wear-and-tear, the presence of oxygen in the pipes, and environmental factors such as extreme temperatures.

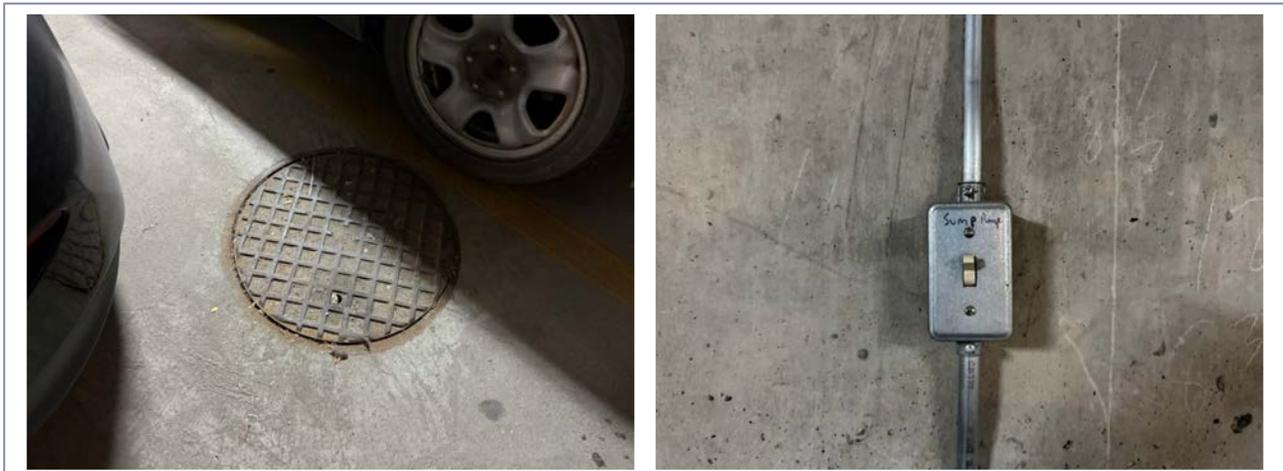
Estimated Current Cost \$1,500	Projected Replacement Cost \$1,600 Due in 2027	Effective Age / Lifespan (years) 10 / 12
Description	This component accounts for the common-element sump pumps. This includes the sump pump system but excludes the sump pit/tank.	
Condition Analysis	We were not able to visually inspect this component. No major deficiencies were reported at the time of inspection, so we assume it to be in average condition for its age.	
Work Completed	Unknown total scope of reserve fund work completed to date.	
Scope of Work	Remove failed sump pump components and replace as required.	
Potential Deterioration	Includes wear-and-tear, pipe damage, gasket deterioration, motor failure, bent impellers, electrical failure, and corrosion. Contributing factors include physical damage, water damage, debris accumulation, infrequent pump usage, having the motor run when there is no water to pump, and environmental factors such as extreme temperatures.

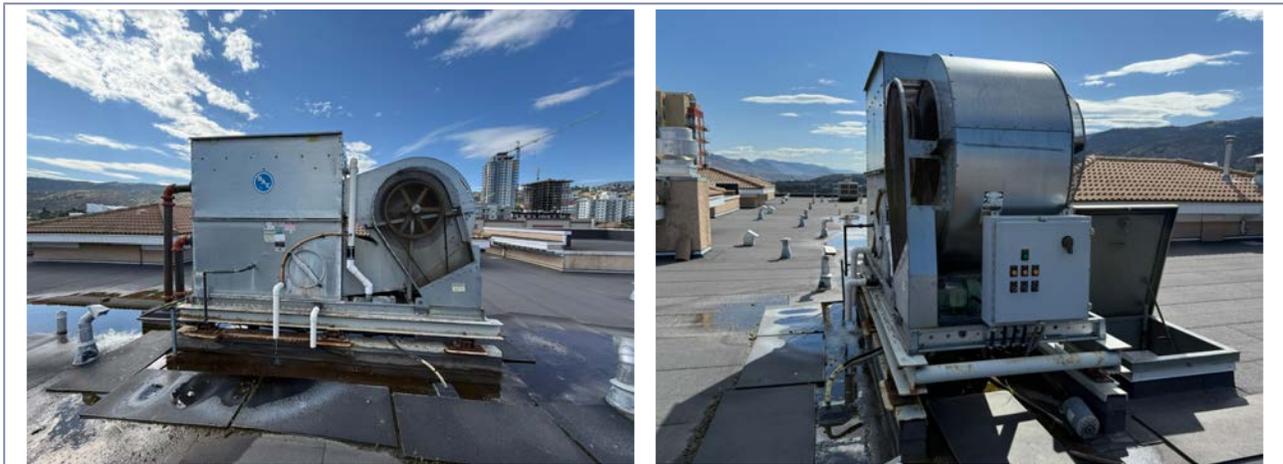
<p>Estimated Current Cost \$117,600 Budget 66%</p>	<p>Projected Replacement Cost \$167,500 Due in 2035</p>	<p>Effective Age / Lifespan (years) 25 / 35</p>
<p>Description</p>	<p>This component accounts for the cooling tower. This includes an allowance for repairs to the cooling tower pumps and water loop piping.</p>	
<p>Condition Analysis</p>	<p>Based on a partial visual inspection, this component appears to be in average condition for its age. No major deficiencies were noted or reported at the time of inspection.</p>	
<p>Work Completed</p>	<p>Unknown total scope of reserve fund work completed to date.</p>	
<p>Scope of Work</p>	<p>Remove and replace the failing components as required. This may involve a lengthy planning phase and disruptive work. Increasing repairs are expected towards the end of the unit's life; replacement parts can sometimes become obsolete and repairs can become so frequent and costly that a full replacement becomes necessary.</p>

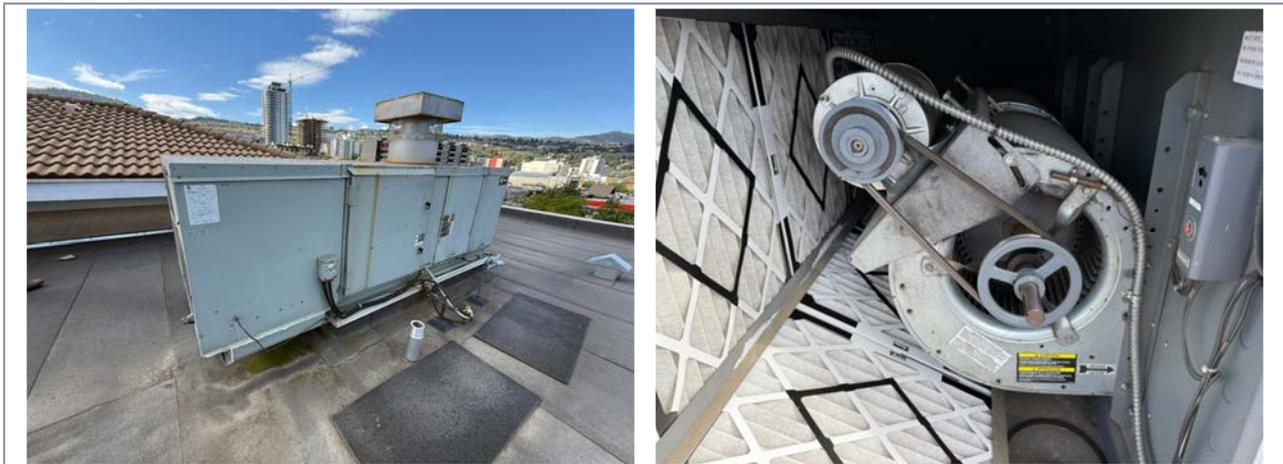
#40 / Building - Mechanical Systems / Make Up Air Unit

Estimated Current Cost \$11,500 Budget 66%	Projected Replacement Cost \$15,800 Due in 2034	Effective Age / Lifespan (years) 11 / 20
--	---	---

Description	This component accounts for the Make-Up Air Unit, an Air Handling Unit that introduces 100% fresh supply air into the HVAC system. This includes the casing, filters, blower, burner, heat exchanger, and associated components.
Condition Analysis	Based on a partial visual inspection, this component appears to be in average condition for its age. No major deficiencies were noted or reported at the time of inspection.
Work Completed	Unknown total scope of reserve fund work completed to date.
Scope of Work	Remove and replace the failing unit. Small repairs and replacements are expected towards the end of the unit's life.
Potential Deterioration	Includes rising energy costs, belt drive failure, fan failure, heat exchanger failure, and controls failure. Contributing factors include wear-and-tear, corrosion, impact damage, debris accumulation, leaks, overheating, insufficient maintenance, insufficient efficiency, and environmental factors such as extreme temperature changes, rain, snow, wind, and sun exposure.

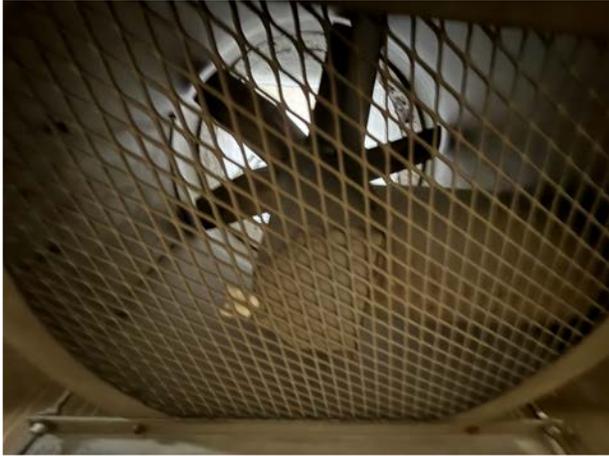
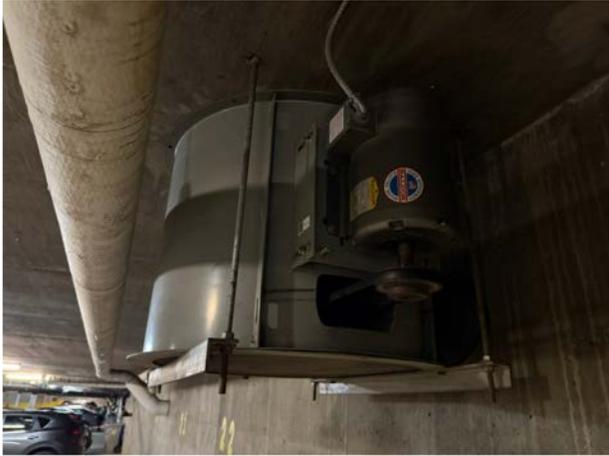
<table border="0" style="width: 100%; text-align: center;"> <tr> <td style="width: 33%;"> Estimated Current Cost \$2,100 Budget 50% </td> <td style="width: 33%;"> Projected Replacement Cost \$2,500 Due in 2030 </td> <td style="width: 33%;"> Effective Age / Lifespan (years) 10 / 15 </td> </tr> </table>		Estimated Current Cost \$2,100 Budget 50%	Projected Replacement Cost \$2,500 Due in 2030	Effective Age / Lifespan (years) 10 / 15
Estimated Current Cost \$2,100 Budget 50%	Projected Replacement Cost \$2,500 Due in 2030	Effective Age / Lifespan (years) 10 / 15		
Description	This component accounts for the parkade exhaust fans.			
Condition Analysis	Based on a partial visual inspection, this component appears to be in average condition for its age. No major deficiencies were noted or reported at the time of inspection.			
Work Completed	Unknown total scope of reserve fund work completed to date.			
Scope of Work	Remove and replace the failed fan parts as required.			
Potential Deterioration	Includes corrosion, high operating costs, air leakage, motor failure, fan failure, and controls failure. Contributing factors include wear-and-tear, physical damage, frequent start-ups, overheating, debris accumulation, and environmental factors such as extreme temperatures and humidity.			
Suggested Maintenance	Regular inspection of the fans for adequate performance. Service and repair as required.

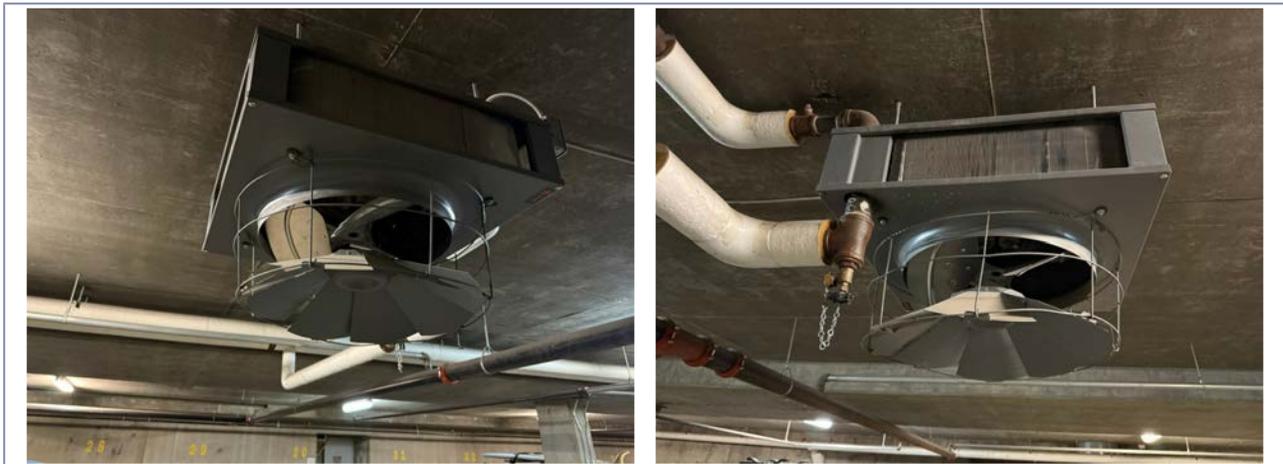
#42 / Building - Mechanical Systems / Parkade Heating System

Estimated Current Cost \$8,500 Budget 50%	Projected Replacement Cost \$10,100 Due in 2030	Effective Age / Lifespan (years) 10 / 15
---	---	---

Description	This component accounts for the parkade fan-forced hydronic unit heater. Connected to a hot water or glycol heating loop (the insulated pipes supply heated fluid). The fan blows air across the finned coil, distributing warm air into the space (in this case, likely a parkade or service garage). The valve with chain is a manual air vent or drain, used for bleeding trapped air or draining the coil.
Condition Analysis	Based on a partial visual inspection, this component appears to be in average condition for its age. No major deficiencies were noted or reported at the time of inspection.
Work Completed	Unknown total scope of reserve fund work completed to date.
Scope of Work	Remove and replace the failed fan parts as required.
Potential Deterioration	Includes corrosion, high operating costs, air leakage, motor failure, fan failure, and controls failure. Contributing factors include wear-and-tear, physical damage, frequent start-ups, overheating, debris accumulation, and environmental factors such as extreme temperatures and humidity.

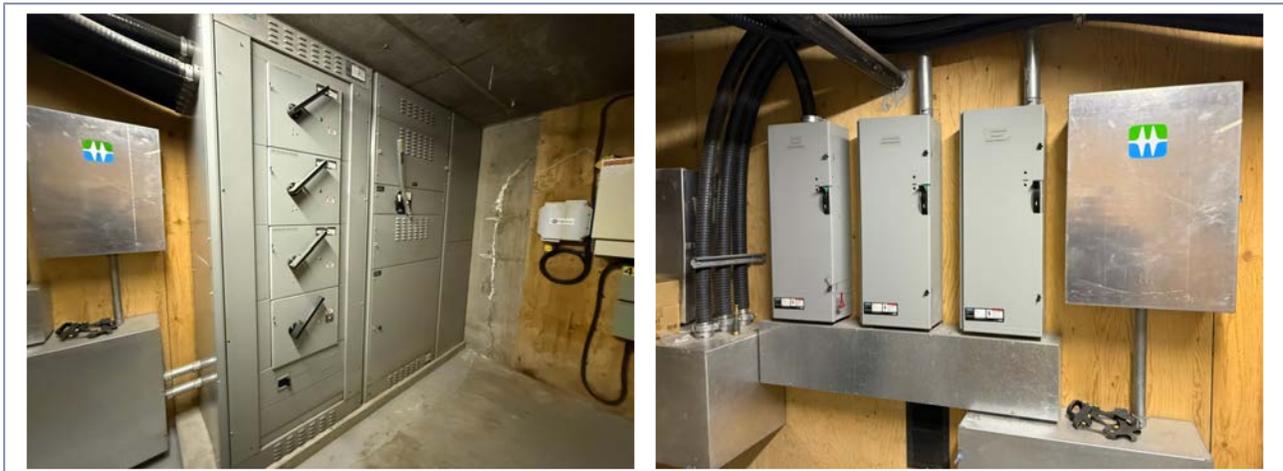
<p>Estimated Current Cost \$29,000 Budget 25%</p>	<p>Projected Replacement Cost \$70,100 Due in 2050</p>	<p>Effective Age / Lifespan (years) 25 / 50</p>
<p>Description</p>	<p>This component accounts for the common-element electrical service and distribution system. This includes wiring, service panels, breakers, switches, receptacles, and various electrical accessories.</p>	
<p>Condition Analysis</p>	<p>Based on a partial visual inspection, this component appears to be in average condition for its age. No major deficiencies were noted or reported at the time of inspection.</p>	
<p>Work Completed</p>	<p>Unknown total scope of reserve fund work completed to date.</p>	
<p>Scope of Work</p>	<p>Remove and replace the various electrical components as required or desired.</p>	
<p>Potential Deterioration</p>	<p>Includes component failure, wire degradation, wire insulation failure, loosening of connections, and insufficient power. Contributing factors include wear-and-tear, usage, load demand, debris accumulation, corrosion, increased power demands, and environmental factors such as extreme temperatures, humidity, and ventilation.</p>

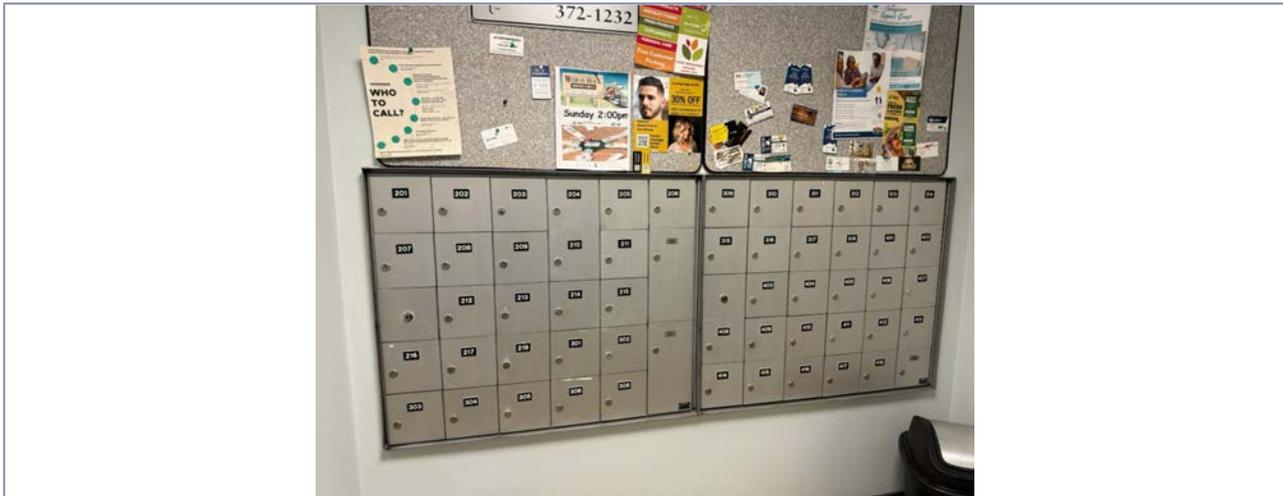
#44 / Building - Amenities / Mailboxes

Estimated Current Cost \$9,200	Projected Replacement Cost \$22,400 Due in 2050	Effective Age / Lifespan (years) 25 / 50
--	--	--

Description	This component accounts for the mailboxes.
Condition Analysis	Based on a partial visual inspection, this component appears to be in average condition for its age. No major deficiencies were noted or reported at the time of inspection.
Work Completed	Unknown total scope of reserve fund work completed to date.
Scope of Work	Remove and replace the failed mailboxes.
Potential Deterioration	Includes impact damage and corrosion. Contributing factors include physical damage, wear-and-tear, and environmental factors such as temperature changes and humidity.
Suggested Maintenance	Regular inspection of the mailboxes for deterioration and vandalism. Clean and repair as required.

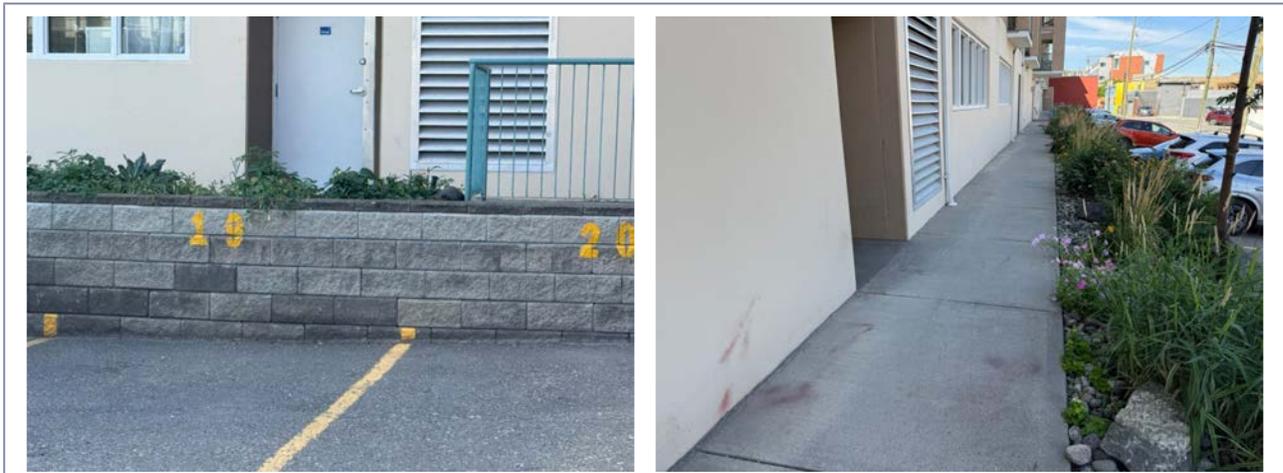
Estimated Current Cost \$2,500 Budget 15%	Projected Replacement Cost \$4,300 Due in 2040	Effective Age / Lifespan (years) 10 / 25
Description	This component accounts for the common-element landscaping. This excludes any routine maintenance that is covered by the operating fund.		
Condition Analysis	Based on a partial visual inspection, this component appears to be in good condition. No major deficiencies were noted or reported at the time of inspection.		
Work Completed	Unknown total scope of reserve fund work completed to date.		
Scope of Work	Regrade as necessary. Replace or repair dead and damaged vegetation. Top up beds. Change landscaping for aesthetic purposes.		
Potential Deterioration	Includes poor grading, impact damage, and wear-and-tear. Contributing factors include physical damage, subsurface shifting, debris accumulation, lack of maintenance, and environmental factors such as extreme temperature changes, rain, snow, wind, and sun exposure.

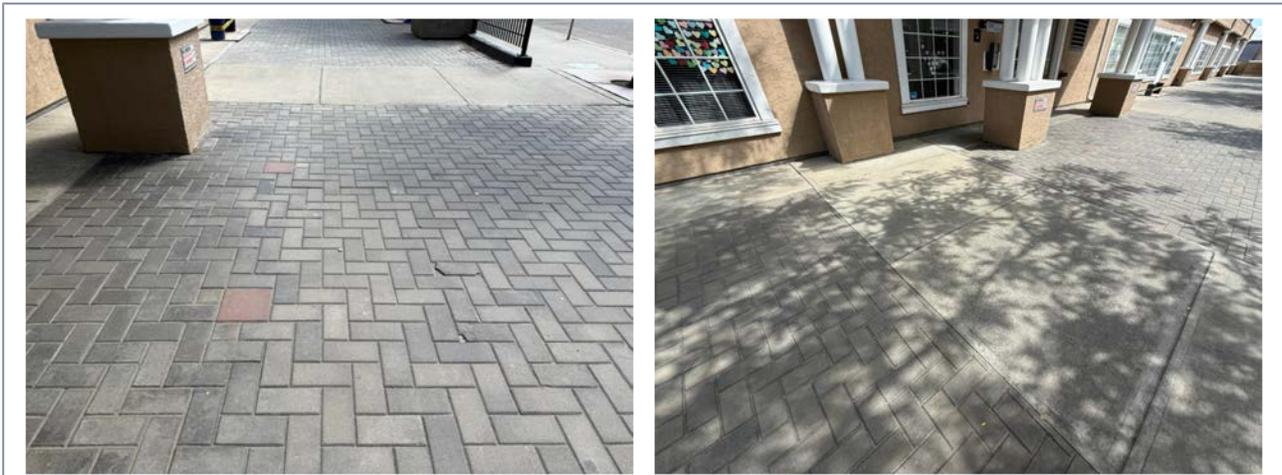
#46 / Common Site Improvements / Pavers

Estimated Current Cost \$27,700 Budget 25%	Projected Replacement Cost \$80,100 Due in 2055	Effective Age / Lifespan (years) 20 / 50
--	---	--

Description	This component accounts for the common-element paving stones.
Condition Analysis	Based on a visual inspection, this component appears to be in average condition for its age. No major deficiencies were noted or reported at the time of inspection.
Work Completed	Unknown total scope of reserve fund work completed to date.
Scope of Work	Remove failing sections and store paving stones nearby. Repair the subgrade and base course as required. Replace pavers: use old pavers where possible.
Potential Deterioration	Includes cracking, crumbling, impact damage, and poor grading. Contributing factors include physical damage, wear-and-tear, debris accumulation, chemical damage (particularly from de-icing chemicals), subsurface shifting, and environmental factors such as temperature changes, rain, snow, and wind.
Suggested Maintenance	Regular inspection of the pavers for deterioration and grading issues. Inspect, clean, replace damaged pavers, and repair as required.

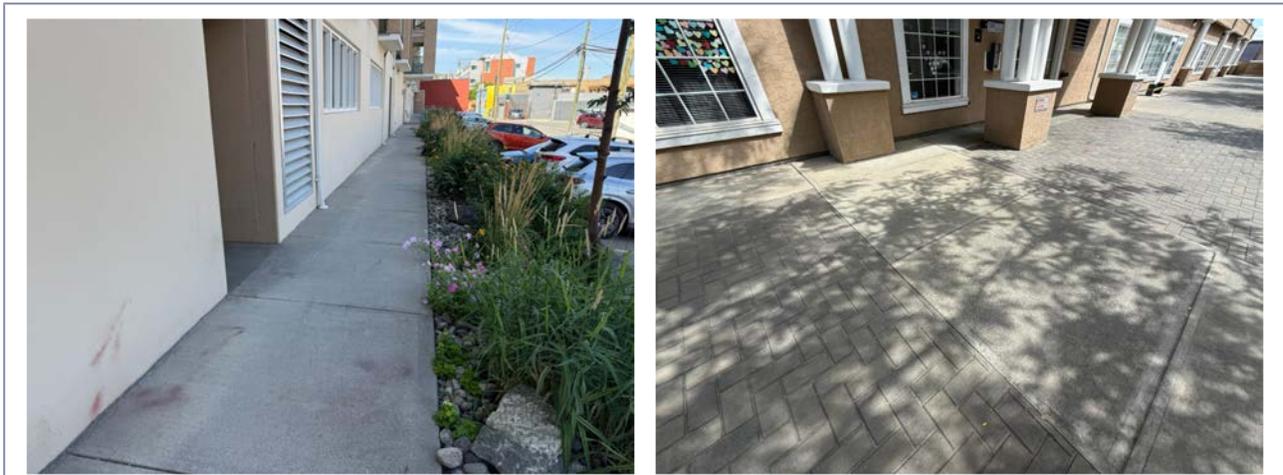
#47 / Common Site Improvements / Concrete Walkways

Estimated Current Cost \$12,700 Budget 50%	Projected Replacement Cost \$30,800 Due in 2050	Effective Age / Lifespan (years) 25 / 50
--	---	---

Description	This component accounts for the concrete walkways.
Condition Analysis	Based on a visual inspection, this component appears to be in average condition for its age. No major deficiencies were noted or reported at the time of inspection.
Work Completed	Unknown total scope of reserve fund work completed to date.
Scope of Work	Break and remove concrete slabs. Repair the subgrade and base course as required. Form and pour concrete with relief joints.
Potential Deterioration	Includes holes, cracking, spalling, delamination, poor grading, ponding water, and expansion joint failure. Contributing factors include impact damage, wear-and-tear, debris accumulation, subsurface shifting, and environmental factors such as temperature changes, rain, snow, wind, and sun exposure.
Suggested Maintenance	Regular inspection of the walkway for deterioration and shifting. Inspect, clean, and repair as required.

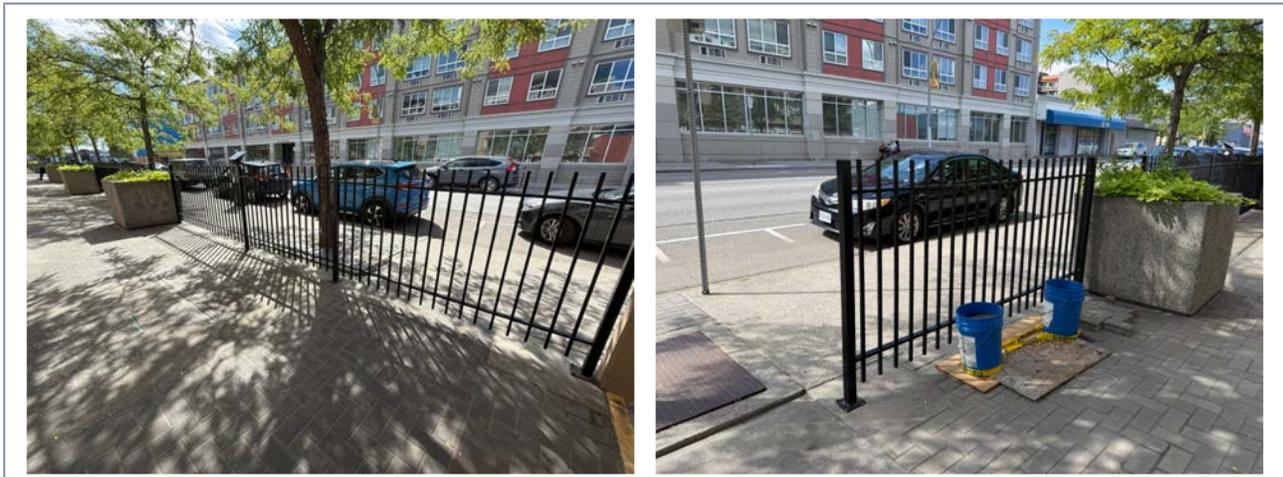
#48 / Common Site Improvements / Metal Fencing

Estimated Current Cost \$15,200 Budget 50%	Projected Replacement Cost \$30,900 Due in 2045	Effective Age / Lifespan (years) 20 / 40
--	---	---

Description	This component accounts for the common-element metal fencing.
Condition Analysis	Based on a partial visual inspection, this component appears to be in average condition for its age. No major deficiencies were noted or reported at the time of inspection.
Work Completed	Unknown total scope of reserve fund work completed to date.
Scope of Work	Remove and replace fencing as required or desired.
Potential Deterioration	Includes impact damage, breakage, corrosion, wear-and-tear, and leaning. Contributing factors include physical damage, subsurface shifting, debris accumulation, lack of maintenance, and environmental factors such as extreme temperature changes, rain, snow, wind, and sun exposure.
Suggested Maintenance	Regular visual inspection of fence for deterioration. Clean and repair as required.

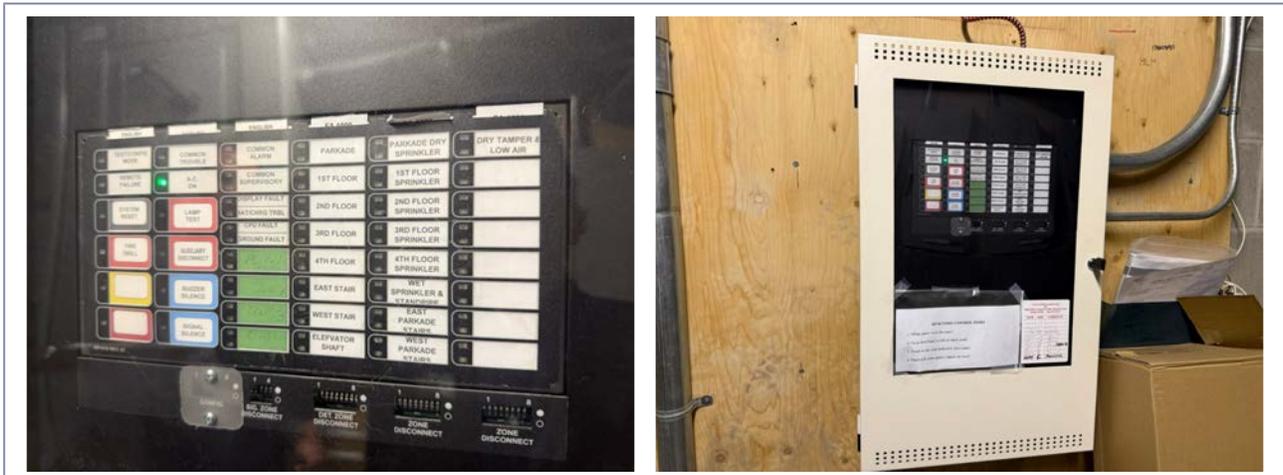
Estimated Current Cost \$18,200 Budget 20%	Projected Replacement Cost \$21,700 Due in 2030	Effective Age / Lifespan (years) 10 / 15
Description	This component accounts for the fire detection and notification system. This includes initiating devices, relays, conduits, wiring, panels, and fire equipment.		
Condition Analysis	Based on a partial visual inspection, this component appears to be in average condition for its age. No major deficiencies were noted or reported at the time of inspection.		
Work Completed	Unknown total scope of reserve fund work completed to date.		
Scope of Work	Repair or replace the various components as required or recommended by qualified fire inspectors.		
Potential Deterioration	Includes component failure, wire degradation, electrical failure, impact damage, and functional obsolescence. Contributing factors include wear-and-tear, usage, debris accumulation, corrosion, physical damage, technological improvements, building code changes, and environmental factors such as extreme temperatures, humidity, and ventilation.

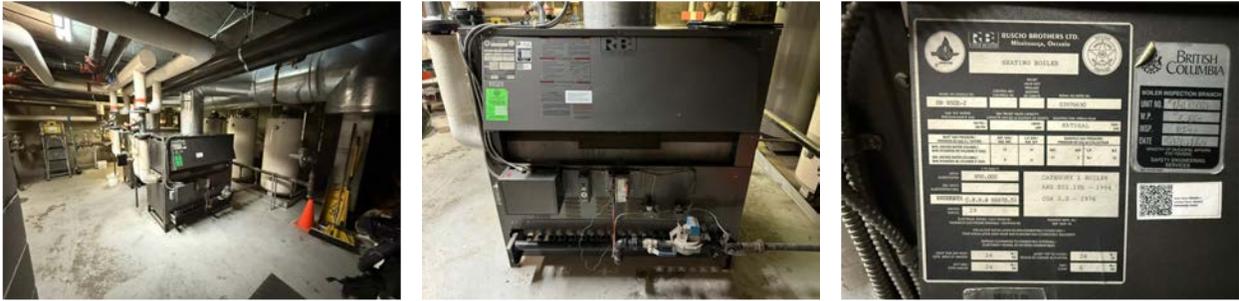
<p>Estimated Current Cost \$61,000</p>	<p>Projected Replacement Cost \$72,800 Due in 2030</p>	<p>Effective Age / Lifespan (years) 20 / 25</p>
Description	<p>This component accounts for the natural gas boiler. This includes the insulating jacket, standard controls, burner, safety controls, breech, trim, fittings, and valves. This excludes the piping and the rest of the heating distribution system, which is accounted for separately in this report.</p>	
Condition Analysis	<p>Based on a partial visual inspection, this component appears to be in average condition for its age. No major deficiencies were noted or reported at the time of inspection.</p>	
Work Completed	<p>Unknown total scope of reserve fund work completed to date.</p>	
Scope of Work	<p>Remove and replace the failing boiler.</p>	
Potential Deterioration	<p>Includes valve, tubing, burner, and fastener failure, leaks, mineral build-up, decreased heating ability, noisy operation, and debris accumulation. Contributing factors include wear-and-tear, corrosion, overheating, insufficient maintenance, excessive pressure in the system, and environmental factors such as extreme temperatures.</p>

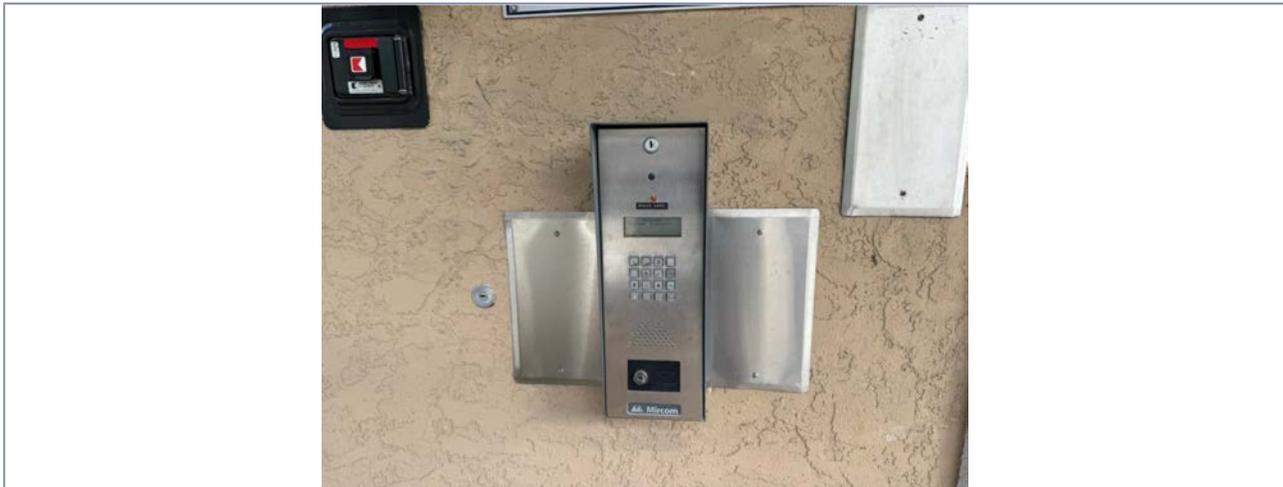
#51 / Building - Electrical Systems / Access Entry System

Estimated Current Cost \$10,600	Projected Replacement Cost \$12,700 Due in 2030	Effective Age / Lifespan (years) 10 / 15
---	--	--

Description	This component accounts for the common-element access entry system. This includes the intercom terminal and door-release system.
Condition Analysis	Based on a partial visual inspection, this component appears to be in average condition for its age. No major deficiencies were noted or reported at the time of inspection.
Work Completed	Unknown total scope of reserve fund work completed to date.
Scope of Work	Remove and replace failing access control systems as required or replace as desired for upgraded security. Integrate the new system with the connected components where possible.
Potential Deterioration	Includes impact damage, electrical failure, component degradation, and functional obsolescence. Contributing factors include wear-and-tear, physical damage, technological improvements, and environmental factors such as extreme temperatures and humidity.
Suggested Maintenance	Regular inspection of the system for vandalism. Be alert to complaints of system failures. Inspect and repair as required.

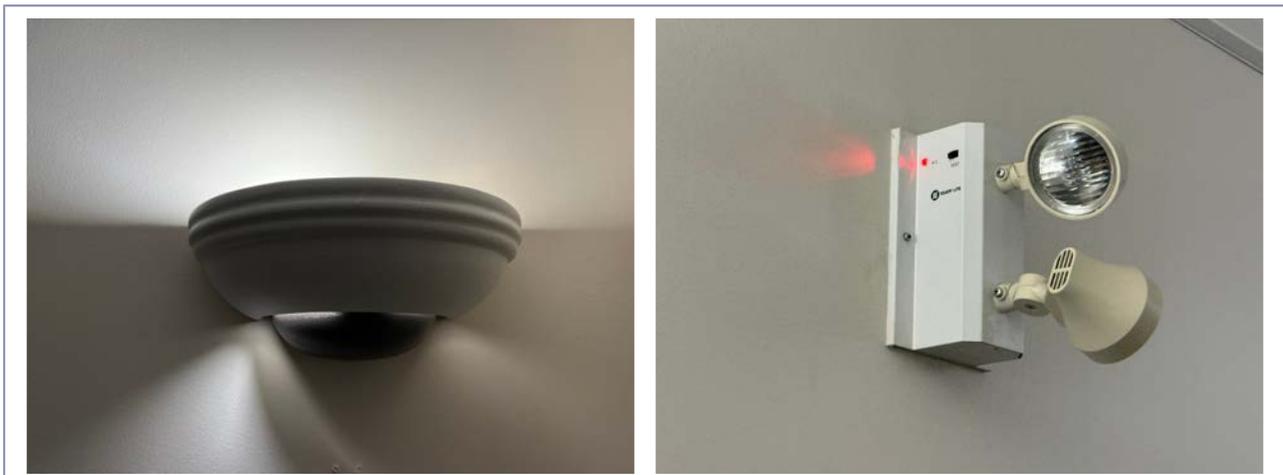
Estimated Current Cost \$26,200 Budget 60%	Projected Replacement Cost \$31,200 Due in 2030	Effective Age / Lifespan (years) 20 / 25
Description	This component accounts for the interior common-area lighting. This includes the fixtures and a small allowance for box and wiring costs.		
Condition Analysis	Based on a visual inspection, this component appears to be in average condition for its age. No major deficiencies were noted or reported at the time of inspection.		
Work Completed	Unknown total scope of reserve fund work completed to date.		
Scope of Work	Remove and replace failed lighting components as required or desired.		
Potential Deterioration	Includes impact damage, electrical component failure, and water damage. Contributing factors include physical damage, power surges, usage, and damage from environmental factors such as temperature changes and humidity. Fixtures may also be replaced due to functional obsolescence or for aesthetic reasons.

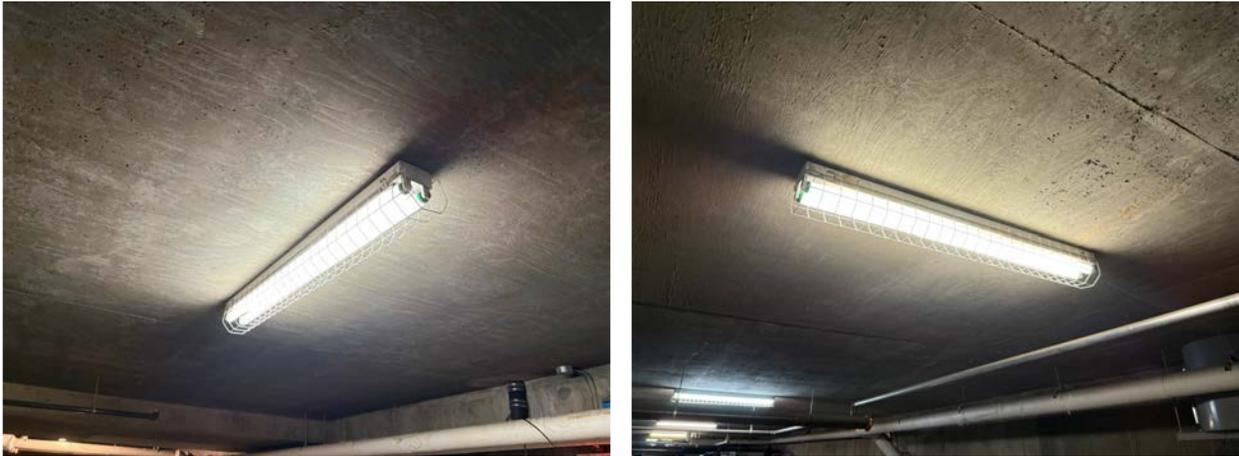
<table border="0" style="width: 100%; text-align: center;"> <tr> <td style="width: 33%;"> Estimated Current Cost \$7,200 Budget 50% </td> <td style="width: 33%;"> Projected Replacement Cost \$8,600 Due in 2030 </td> <td style="width: 33%;"> Effective Age / Lifespan (years) 15 / 20 </td> </tr> </table>		Estimated Current Cost \$7,200 Budget 50%	Projected Replacement Cost \$8,600 Due in 2030	Effective Age / Lifespan (years) 15 / 20
Estimated Current Cost \$7,200 Budget 50%	Projected Replacement Cost \$8,600 Due in 2030	Effective Age / Lifespan (years) 15 / 20		
Description	This component accounts for the lighting in the underground parking area. This includes the fixtures and a small allowance for box and wiring costs.			
Condition Analysis	Based on a visual inspection, this component appears to be in average condition for its age. No major deficiencies were noted or reported at the time of inspection.			
Work Completed	Unknown total scope of reserve fund work completed to date.			
Scope of Work	Remove and replace failed lighting components as required or desired.			
Potential Deterioration	Includes impact damage, electrical component failure, and water damage. Contributing factors include physical damage, power surges, usage, and damage from environmental factors such as temperature changes and humidity. Fixtures may also be replaced due to functional obsolescence or for aesthetic reasons.			
Suggested Maintenance	Regular visual inspection of the fixtures for damage. Regular replacement of bulbs as required. Limit on/off cycles.

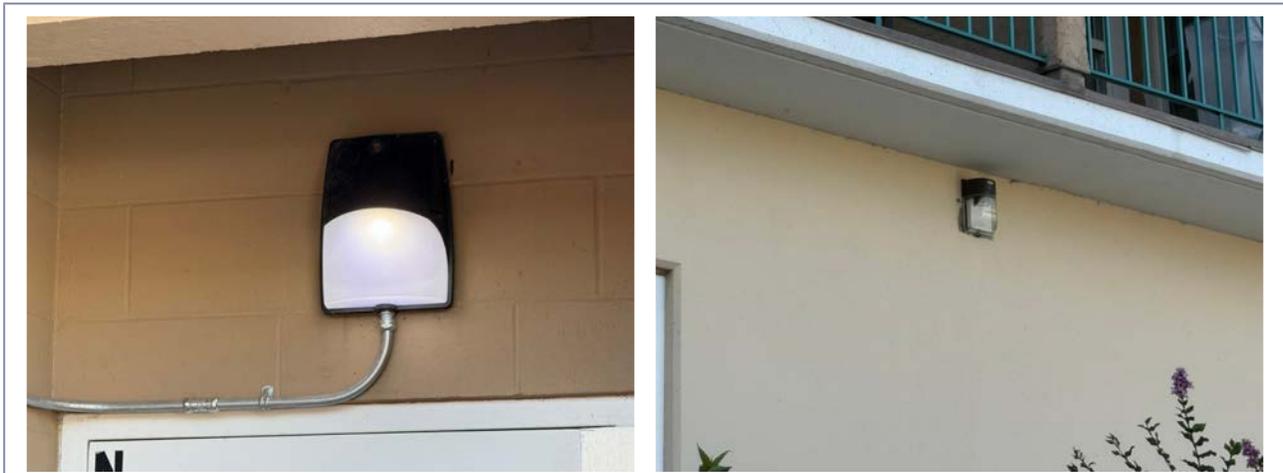
Estimated Current Cost \$15,600 Budget 15%	Projected Replacement Cost \$20,000 Due in 2032	Effective Age / Lifespan (years) 18 / 25
Description	This component accounts for the common-element exterior lighting. This includes the fixtures and a small allowance for box and wiring costs.		
Condition Analysis	Based on a visual inspection, this component appears to be in average condition for its age. No major deficiencies were noted or reported at the time of inspection.		
Work Completed	Unknown total scope of reserve fund work completed to date.		
Scope of Work	Remove and replace failed lighting components as required or desired.		
Potential Deterioration	Includes impact damage, electrical component failure, and water damage. Contributing factors include physical damage, power surges, usage, and damage from environmental factors such as extreme temperature changes, rain, snow, wind, and sun exposure. Fixtures may also be replaced due to functional obsolescence or for aesthetic reasons.

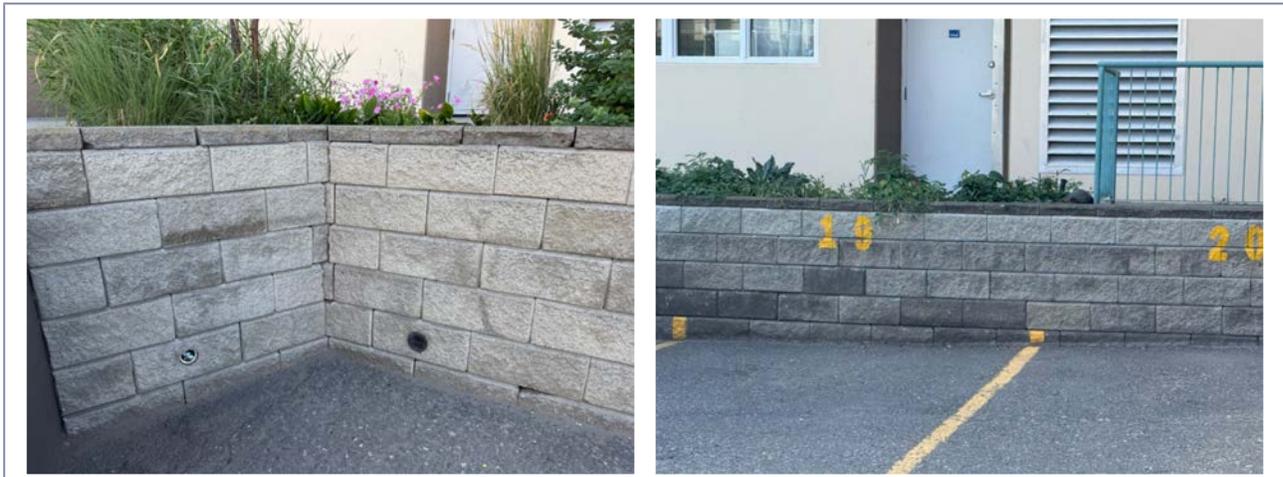
<p style="text-align: center;">Estimated Current Cost \$29,000 Budget 15%</p>	<p style="text-align: center;">Projected Replacement Cost \$58,900 Due in 2045</p>	<p style="text-align: center;">Effective Age / Lifespan (years) 20 / 40</p>
<p>Description</p>	<p>This component accounts for the common-element concrete retaining wall system.</p>	
<p>Condition Analysis</p>	<p>Based on a visual inspection, this component appears to be in average condition for its age. No major deficiencies were noted or reported at the time of inspection.</p>	
<p>Work Completed</p>	<p>Unknown total scope of reserve fund work completed to date.</p>	
<p>Scope of Work</p>	<p>Remove damaged sections. Install new retaining wall system with proper drainage.</p>	
<p>Potential Deterioration</p>	<p>Includes impact damage, cracking, spalling, water damage, buckling, and leaning. Contributing factors include physical damage, subsurface shifting, debris accumulation, improper installation, poor drainage, and environmental factors such as temperature changes, rain, snow, wind, and sun exposure.</p>
